**PRELIMINARY**  
**KNKT.15.03.08.04**

**Aircraft Accident Investigation Report**

**PT. Hevilift Aviation Indonesia  
Sikorsky S76 C+ Helicopter; PK-FUP  
Delta Mahakam river, East Kalimantan  
Republic of Indonesia  
21 March 2015**

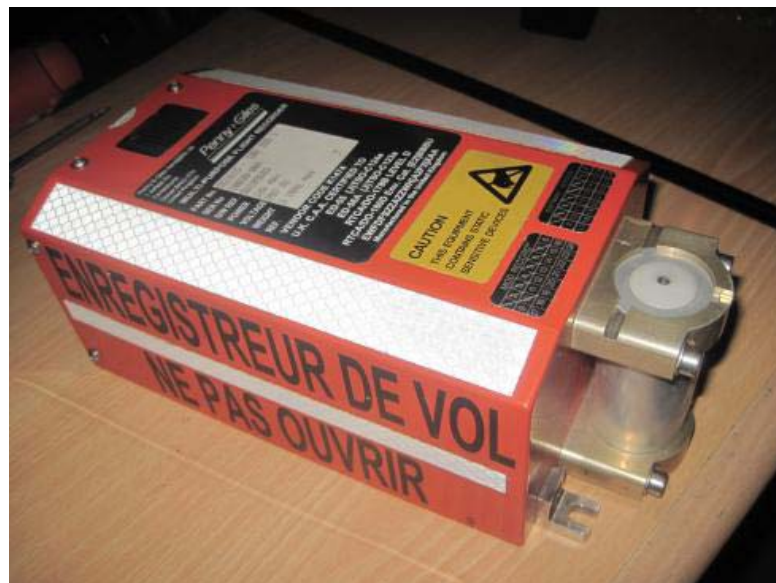
Figure 1.The MPFR

The aircraft was equipped with a Penny & Giles solid state Multi-Purpose Flight Recorder and received at the KNKT recorder laboratory on 24 March 2015. The details information of the MPFR was:

Manufacturer : Penny & Giles Aerospace Ltd.  
Type/Model : Multi-Purpose Flight Recorder  
Part Number : D51612-102 ISS:1  
Serial Number : 18038-004

The MPFR was downloaded on 7 April 2015 at the ATSB facility in Canberra,

Australia. The recorder contained about 70 parameters of 80 hours in good quality data comprising the accident flight and previous flights, included 30 minutes of audio on four channels (P/A, Co-pilot, Pilot, Cockpit Area Microphone/CAM) and 120 minutes of audio on two channels (Combined Crew Audio & CAM).

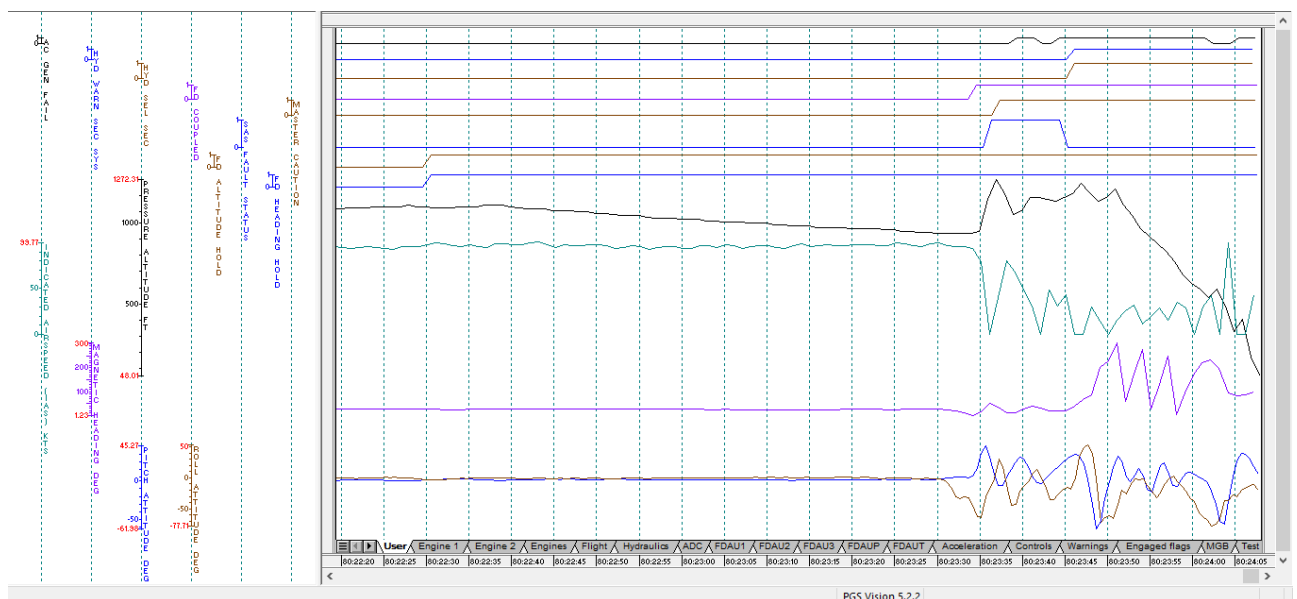
Figure 2. The Sequence of event recorded by flight recorder

When the aircraft 8 Nm from CPU the PIC ask the PF descend to 600 feet, the aircraft start descend 200 feet/minute. While the aircraft passing 800 feet suddenly the aircraft attitude changed un-commanded. The aircraft bank to the left, pitch up and nose down. The PF tried to lower collective pitch and reduce the aircraft speed. The PIC took over the control and tried to recover the aircraft until the aircraft impacted the tree and crash into a swamp.

When the aircraft passing 800 feet the aircraft attitude changed un-commanded, the aircraft bank to the left, pitch up and then nose down, the aircraft hit a tree and crash into a swamp. The aircraft was substantially damaged.

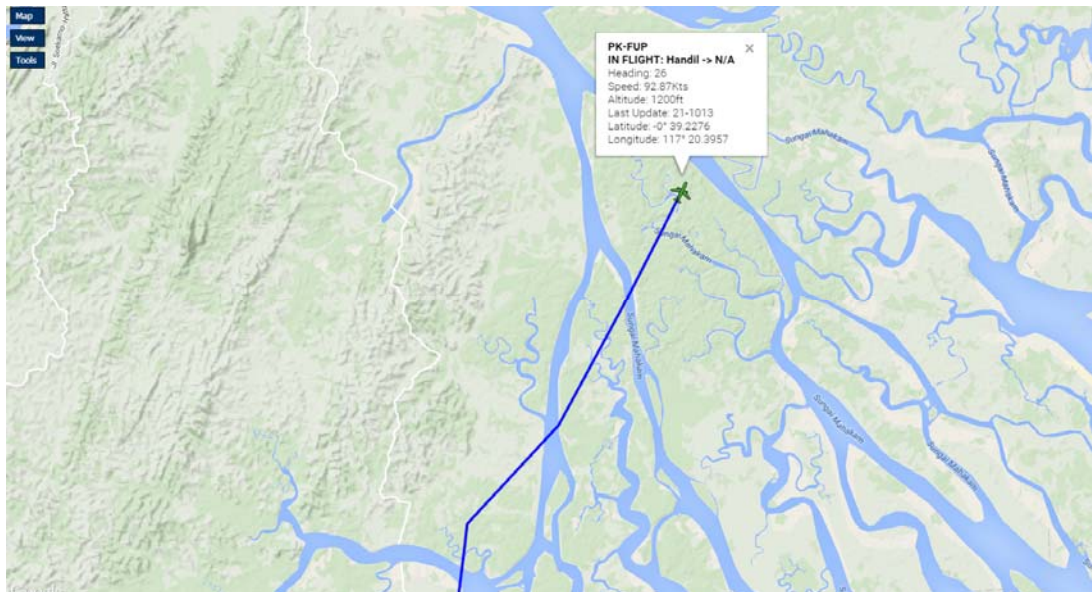
**Figure 3. The aircraft PK-FUP accident route recorded in the Skynet.**

The last aircraft position at coordinate 00° 38.035 S 117° 20.896 E.

The operator utilized flight following system by Skynet. This system was capable of monitoring the flight path as the data were transmitted by the aircraft periodically.
