PRELIMINARY  
KNKT.15.12.28.04

Aircraft Accident Investigation Report

**PT. KalStar Aviation  
Embraer 190-200LR; PK-KDC  
El Tari Airport  
Kupang, Nusa Tenggara Timur  
Republic of Indonesia  
21 December 2015**

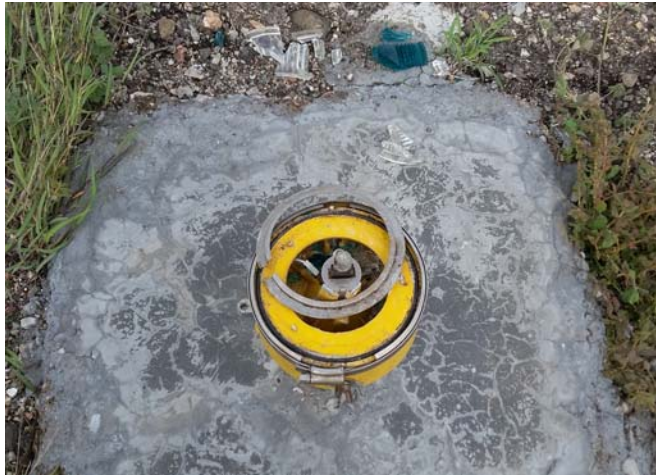
**Figure 2: The broken runway light**

There was a broken runway light at the end of runway 07.

The investigation found tire marks on the runway indicated that aircraft started to veer to the right approximately 220 meters before end of runway 07. At the end of runway 07, there was a broken runway light (most likely struck by the aircraft).

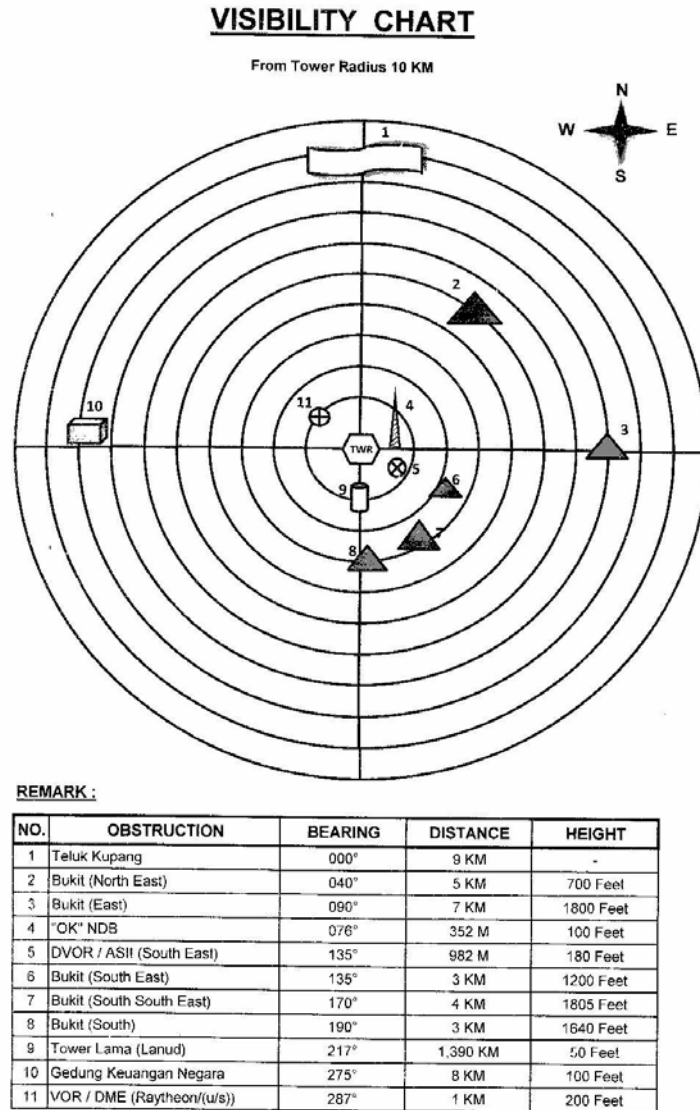
**Figure 5: Visibility chart**

There were several landmarks that used as reference point to determine the visibility. The landmarks were selected to provide visibility information. The investigation could not find the standard operating procedure that describes the usage the visibility chart.

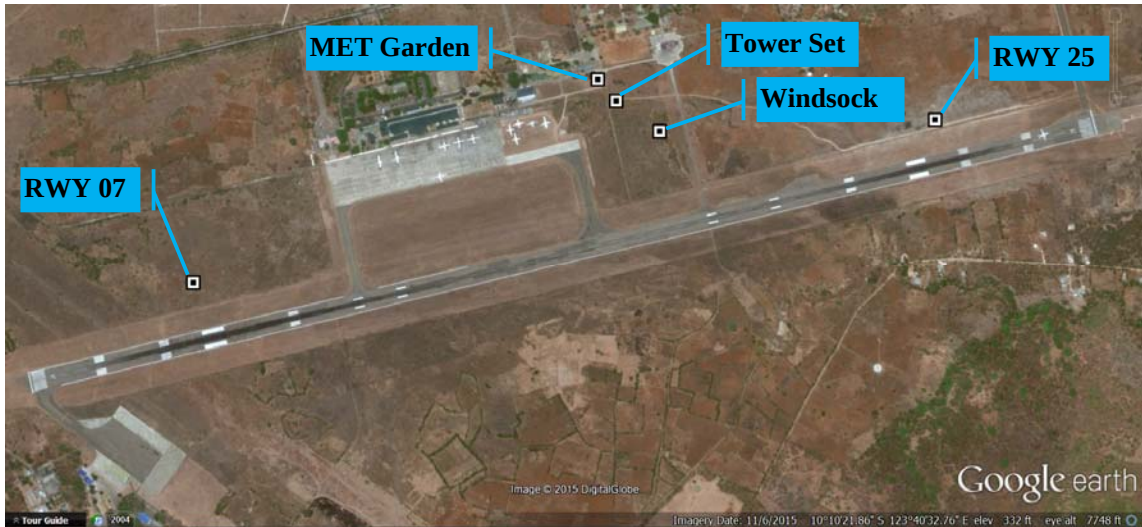
**Figure 6: Meteorological sensor and windsock locations**

There were three different sources that provided the latest wind information to ATC – AWOS display, Tower Set display and wind shock. Based on interview, the ATC stated that they used the information from AWOS display of runway 07 and windsock near tower building as comparison before providing the latest wind condition to the pilot of the accident flight.

The investigation could not find the standard operating procedure that described how to determine the wind information with three different sources.

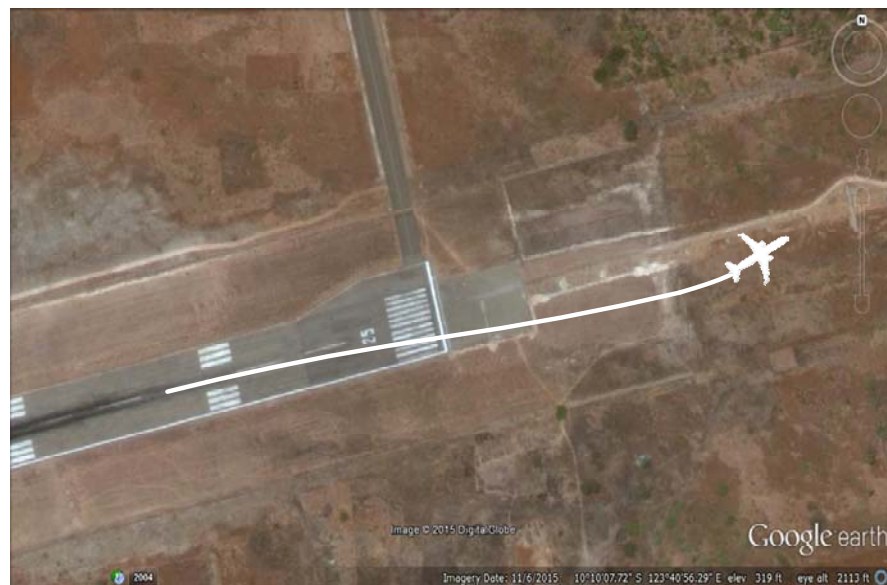
Figure 9: Illustration of accident

About 100 meters from the end of runway 07, there was a ground indentation about 20 centimeters depth. The right main wheel marks ended before this indentation and changed to the marks of engine cowling.

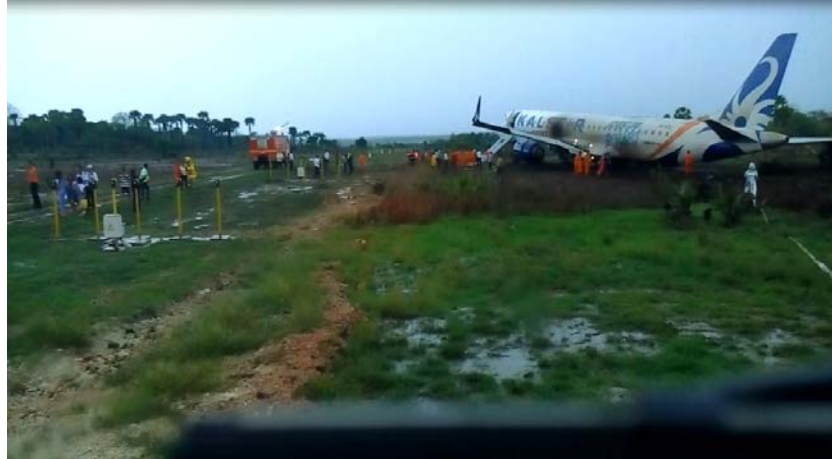
**Figure 10: the aircraft final position**

The aircraft stopped approximately 200 meters from the end of runway 07 with heading 060° and the nose wheel lifted about 50 centimeters from ground.

All the landing gears were extended except for the right main landing gear which was found collapsed and collided with the right inner flap.

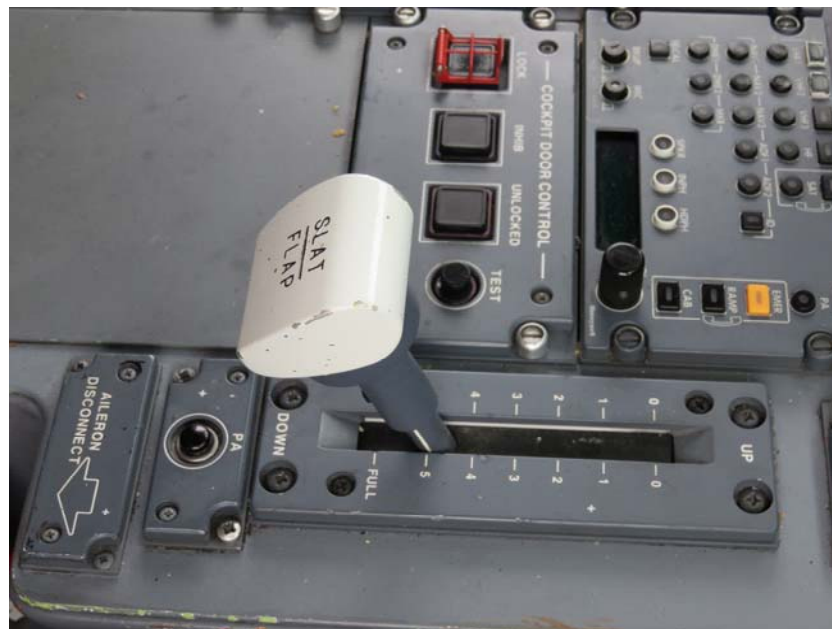
**Figure 11: The flap selector observed at aircraft final position**

The all flaps were extended. All engine reverser were opened and the right engine reverser doors detached and found about 35 meters behind the aircraft.
