**KOMITE NASIONAL KESELAMATAN TRANSPORTASI  
REPUBLIC OF INDONESIA**

## **KNKT16.05.14.04**

### **Aircraft Serious Incident Investigation Report**

**Hong Kong Airlines  
Airbus 330-223; B-LNE  
Near Banjarmasin  
Republic of Indonesia  
6 May 2016**

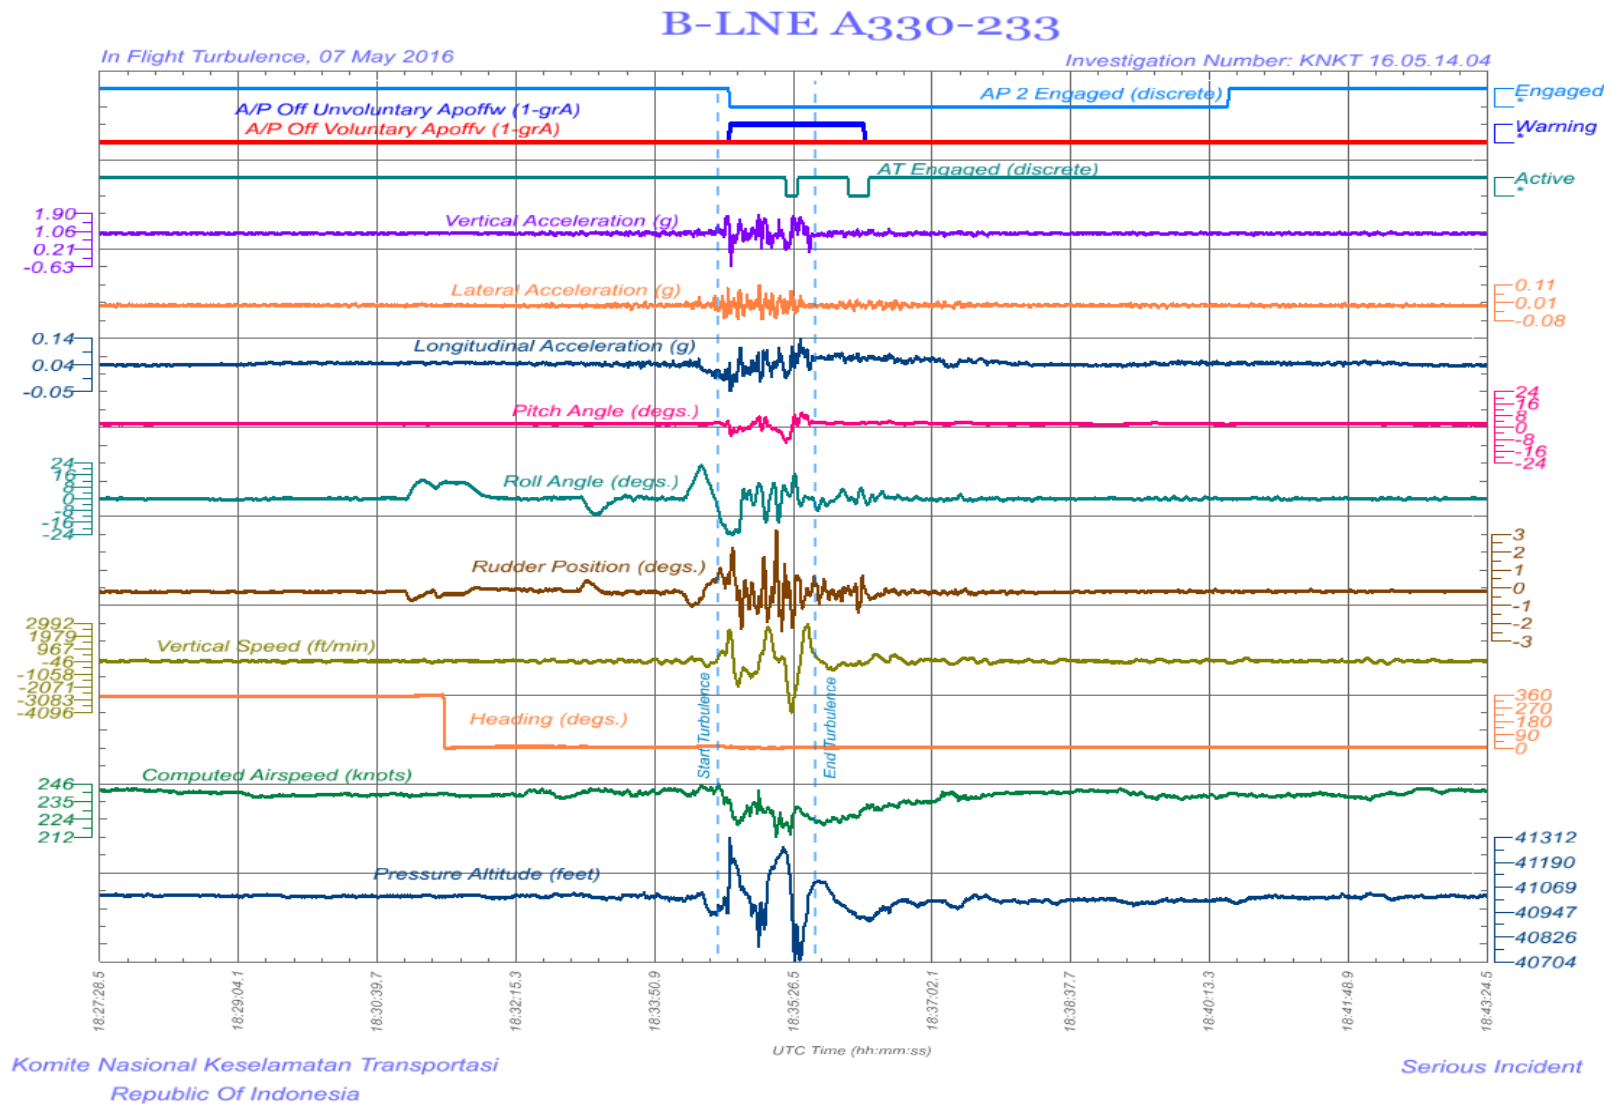
**Figure 6: The significant FDR parameters**

5. At 18:34:35 UTC, fluctuations on the roll angle, rate of descend and speed were observed. The speed was 246 kts (Mach 0.82), decreased toward green dot of 227 kts.

6. Several transient AoA excursions beyond AoA protection threshold led to the transient activation of High Angle of Attack (AoA) protection several times.

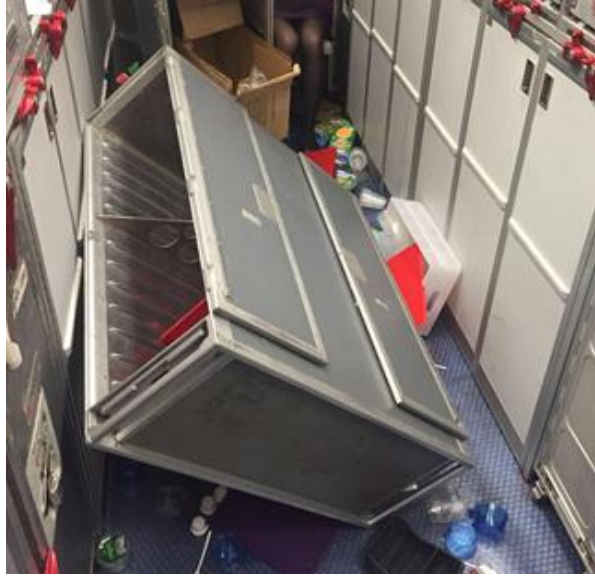
After finishing the meal service, the flight attendants were clearing up the food carts in the aft galley when the sudden turbulence occurred. In the aft galley, three flight attendants and two food carts lifted and hit the ceiling then fell back on the floor.

There were some damages on the ceiling and two food carts fell back to the floor.

**Figure 10: The aft galley condition after encounter turbulence**

15. The severe turbulence occurred when the flight attendants were clearing up of the food carts in the aft galley and caused the two food carts in the aft galley and several occupants were lifted and hit the ceiling then fell back on the floor.

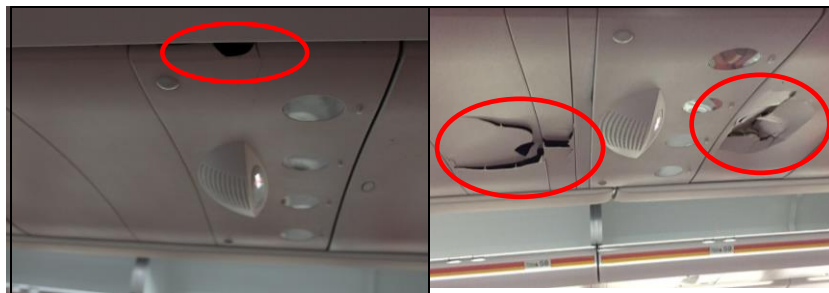
The aircraft had minor damage on the several passenger service units and the aft galley ceiling.

Several passengers service units damaged found above passenger seats number 11A, 11C, 46C, 57E, 58F, 58G, 59F and 59G.

**Figure 11: Damage on passenger service units**

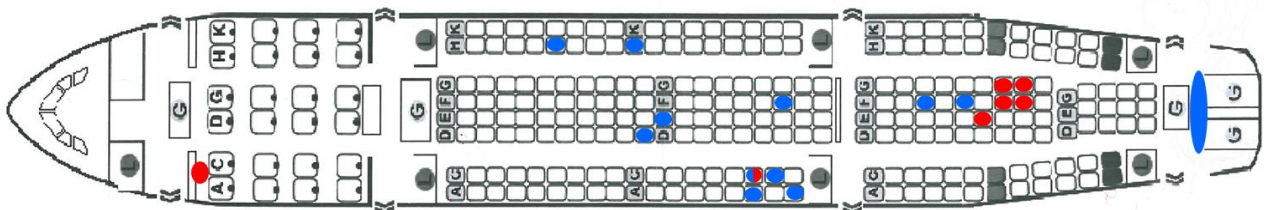
**Figure 12: Position of ceiling damage (red marks) and seat position of the injured occupants (blue marks)**

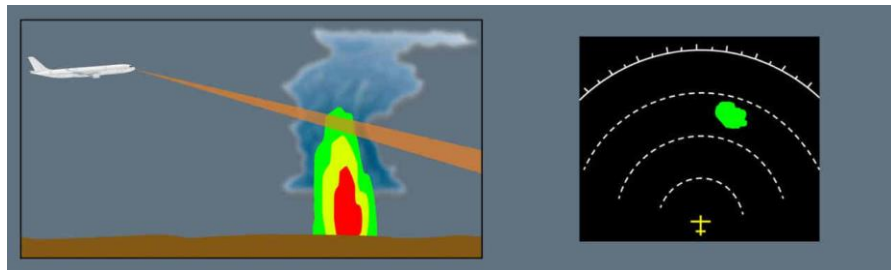
Overscanning

- Over scanning from the weather radar was most likely made storm that may have low reflectivity cell including the associated turbulence was undetected and the flight directed to the turbulence area.
- The absence of the turbulence encounters pre-warned resulted in the flight attendants did not prepare to secure the carts nor to be seated with fastened seatbelt.
- The improper fastened of the passenger seatbelt increased the severity of the passenger injury despite the flight crew had ensured the passenger to fasten their seatbelt.

*At high altitude, a storm cell may contain ice particles that have low reflectivity. If the tilt setting is not correct, the ND may display only the upper (less reflective) part of a storm cell (overscanning). As a result, the flight crew may underestimate or not detect a storm cell.*
