**KNKT.23.05.05.04**

**Aircraft Accident Investigation Report**

**Cessna C208; PK-HVG**

**Yabi Airstrip, Papua**

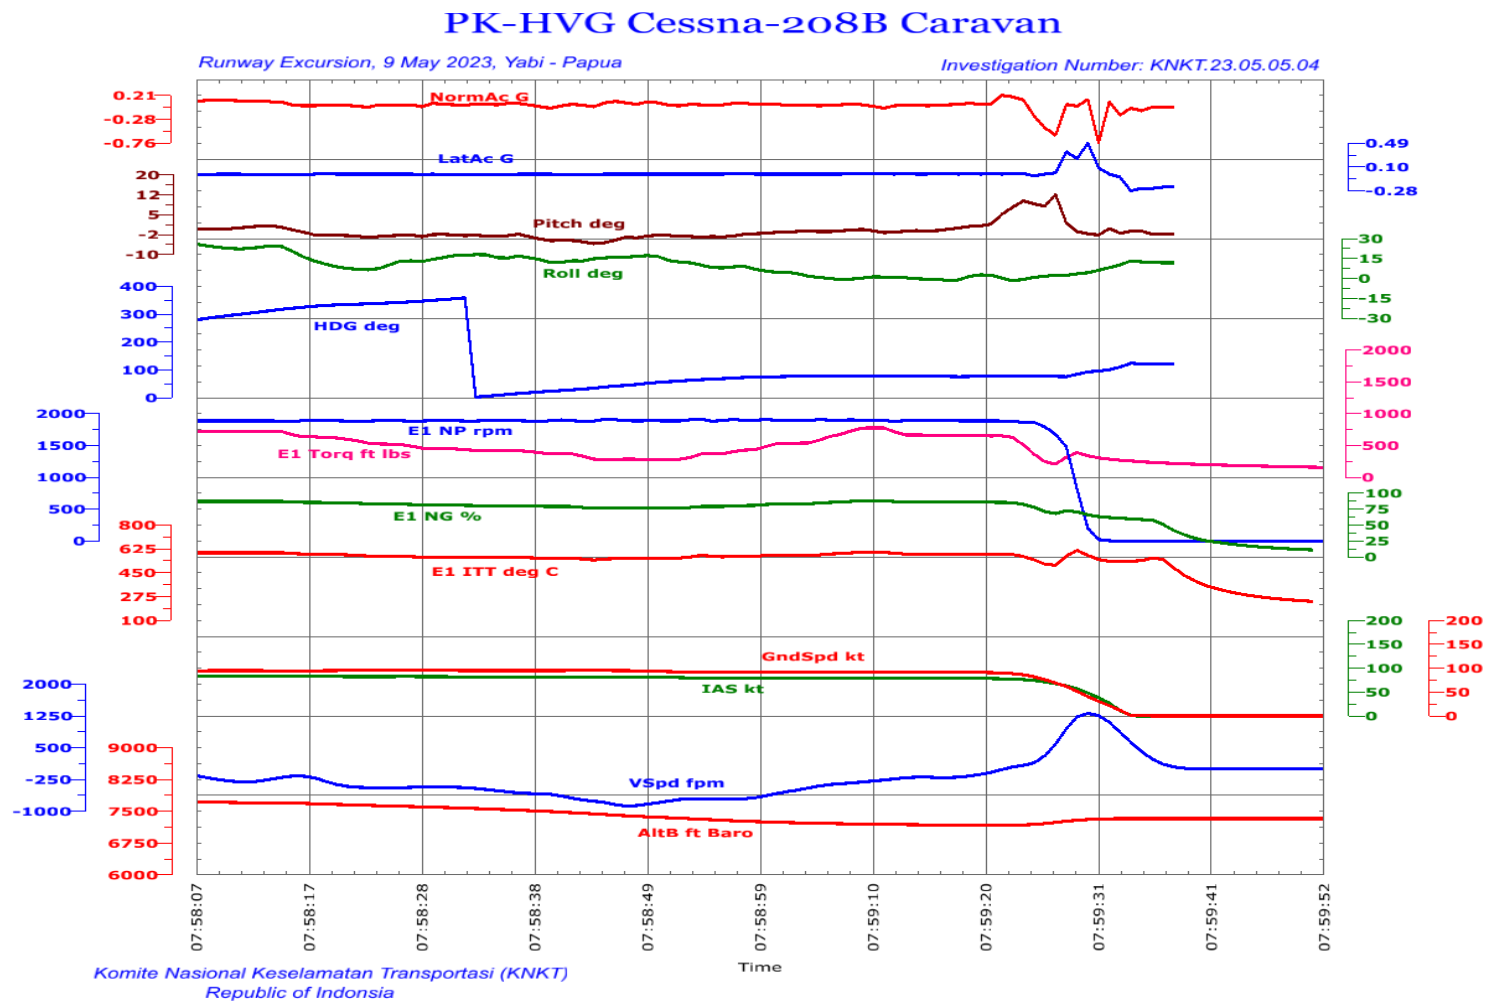
**Figure 4: Aircraft landing plot**

At 7:59:27 LT, the Garmin G1000 flight data logging recorded the NormAc was -0.6 g, meaning that the aircraft experienced an upward force, with the aircraft pitch at 12.61°, and the GndSpd was 68 knots. At this time the aircraft was traveling 34 meters from the previous point. The aircraft roll was recorded at 2.44°, and the aircraft started to veer to the right. Between this point and the previous point, the investigation team discovered a fragment of the nose landing gear spring (drag link spring) and the broken bolt of the nose gear spring attachment.

Following the touchdown, NormAc was recorded at 0.18 g and decreased to 0.12 g. At that period the vertical speed (VS<sub>pd</sub>) reduced from 48 feet per minute (fpm) to 84 fpm. These data indicated that the aircraft bounced. The pilot might have not realized the bounce, as the runway upslope condition may have restored the aircraft's attitude.

KNKT investigation identified that the aircraft was landing with insufficient pitch attitude relative to the steep runway slope. This condition resulting in a nose-low attitude at the moment of touchdown, likely led to the failure of the nose gear and subsequent runway excursion. The investigation did not find any guidance materials related to upslope landing technique. The absence of guidance materials may contributed to the improper handling.

Therefore, KNKT recommends Dimonim Air ensure that the pilots are familiar with visual illusion during landing approach to improve situational awareness and ensure safer operations into remote and terrain-challenged locations.

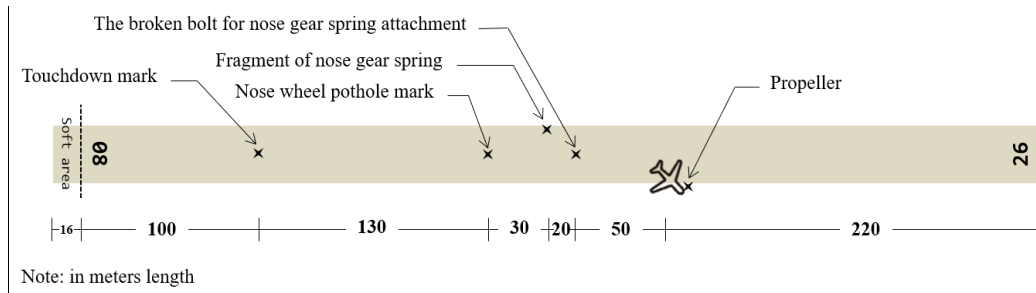
The touchdown mark was found about 100 meters from the beginning of the runway. Approximately 130 meters further, a mark indicating the nose wheel pothole was identified.

**Figure 5: Impact sequence and wreckage trail**

7. Touch down mark was found 102 meters from the beginning of the runway, and the nose wheel pothole mark was identified at a distance of 234 meters. The aircraft came to a stop approximately 330 meters from the beginning of the runway, at the right side of the runway, after executing a right turn, colliding with a large rock which led to the disassembly of the propeller from the engine power drive.

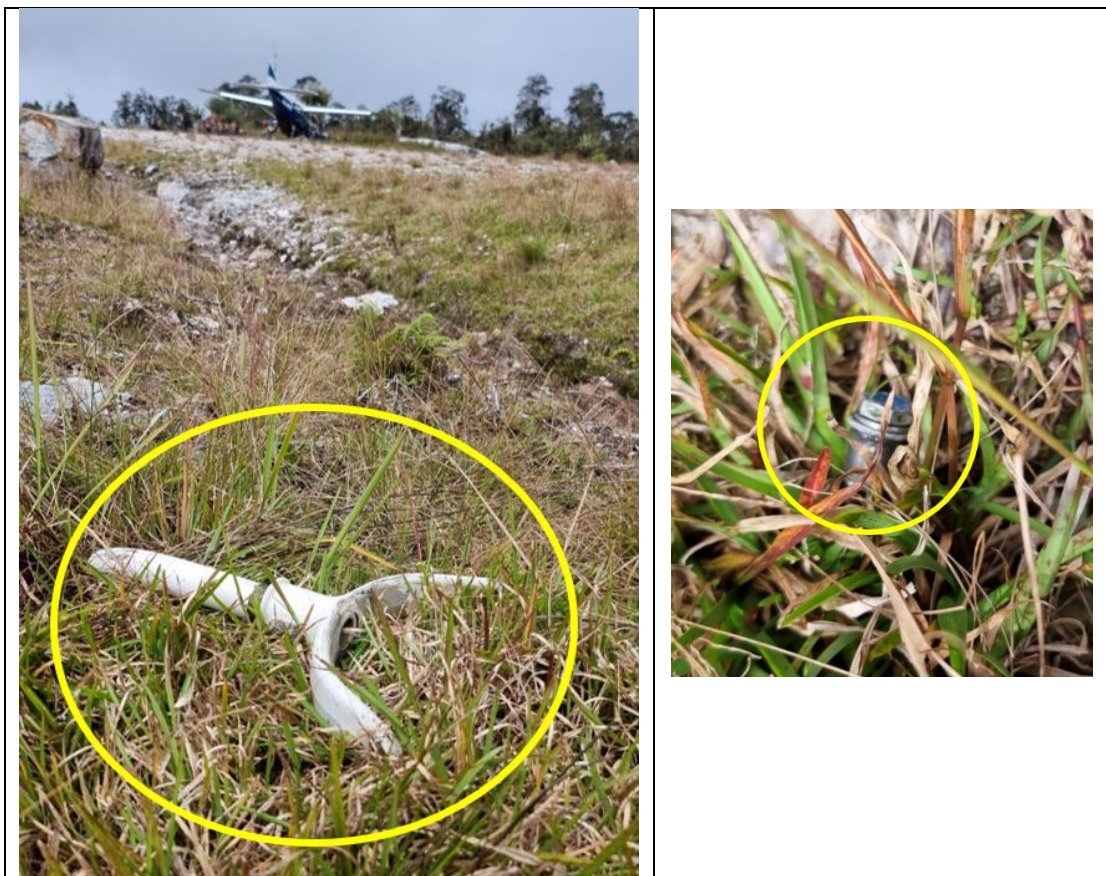
A fragment of the nose landing gear spring (drag link spring) was discovered about 260 meters from the beginning of the runway, with the broken bolt used for the nose gear spring attachment found approximately 20 meters beyond that point.

**Figure 6: The fragment of the nose landing gear spring (drag link spring) and the broken bolt used for the nose gear spring attachment**

As the runway slope continued, negative g values of -0.45 g and followed by -0.6 g, may indicate that the aircraft experienced another upward force. The fragment of the nose landing gear spring (drag link spring) and a broken bolt were found within this distance, indicating that such a force damaged those components.

10. The nose landing gear collapsed. A fragment of the nose landing gear spring was discovered 271 meters from the beginning of the runway, and the bolt used for the nose gear spring attachment was found 14 meters further along from that point. Scattered fragments of the reduction gear box were found along the trail as the aircraft made a right turn before stopped.

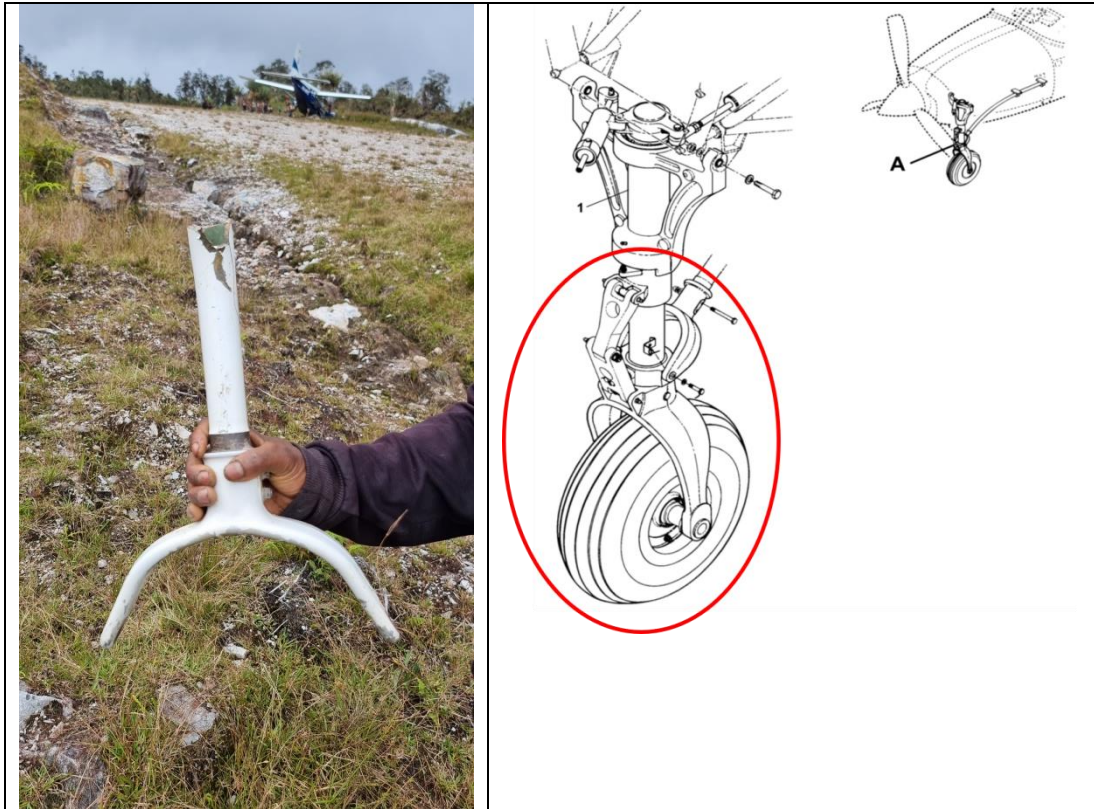
The nose landing gear spring (drag link spring) showed evidence of widening in the fork end compared to the normal size, as shown in Figure 7.

**Figure 7: The widening of the nose gear spring (drag link spring) fork end**

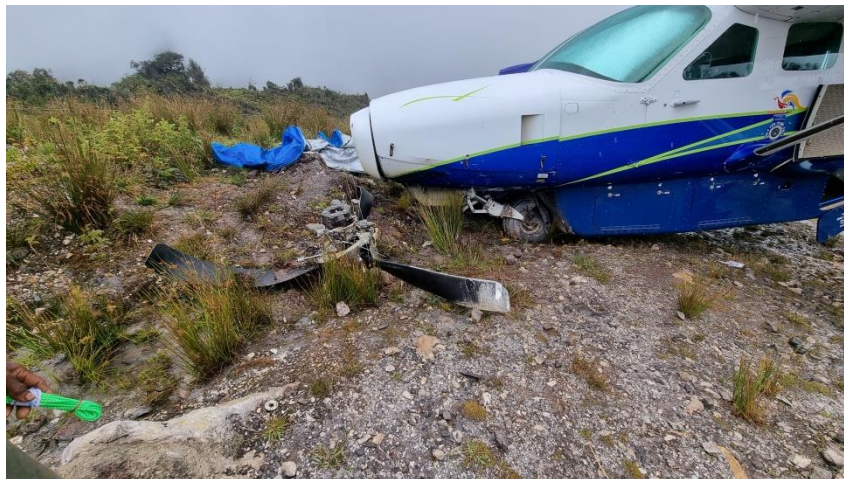
The propeller, which had detached from the engine power drive, was located approximately 0.5 meters to the left of the aircraft's nose, as shown in Figure 8. The investigation team did not find any propeller scratches on the runway.

**Figure 8: The detached propeller was adjacent to the aircraft**

Subsequently, the aircraft veered to the right as indicated by the change in heading and a positive roll attitude, while eventually out of the runway and stopping after colliding with a rock. Considering there was no scratch on the runway, it might indicate that the nose landing gear was still intact during the veering to the right and broken after colliding with the large rock.
