**Marine Casualty Investigation Report**

**Fatality on Board**

**MARINER (IMO 9433559 )**

**21 January 2018**

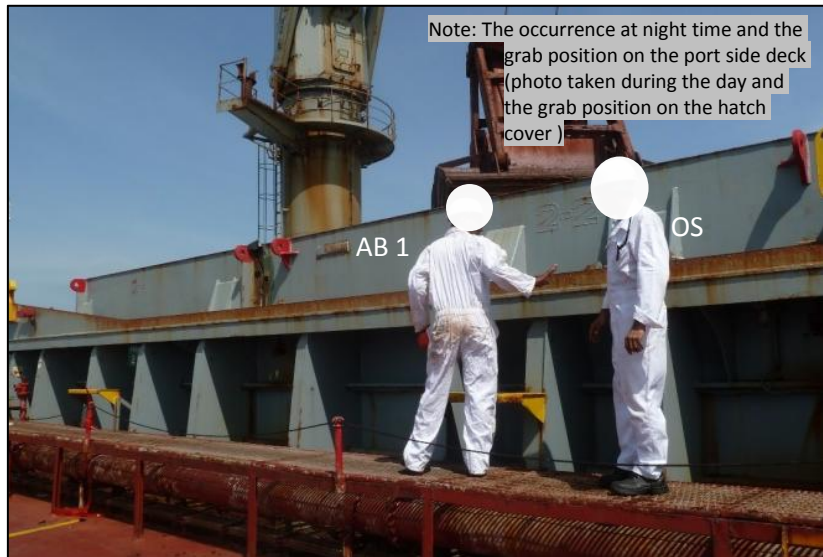
Figure 2: The illustration of AB 1 orders the OS to stop

At 23.25 LT, Crane Operator No. 1 lifted the last bucket from the barge into Hold No. 1. After unloading the last bucket, Crane Operator No. 1 placed the grab (A grab or grip is a tool used to load and unload bulk cargo in the form of a clamshell or bucket) crane with the closed position on the port side deck near the Hatch No. 2 (Figure 4) while waiting for the next barge. The position of the operator's cab was facing the port side of the vessel and the grab steel wire rope is slightly slack. Seeing the Crane Operator No. 1 placing his grab on the port side deck, the AB 1 from the watch station gave a signal using a flashlight to the operator's cabin of the Crane No. 1 with the intention of asking the crane operator to move the grab to the starboard deck.

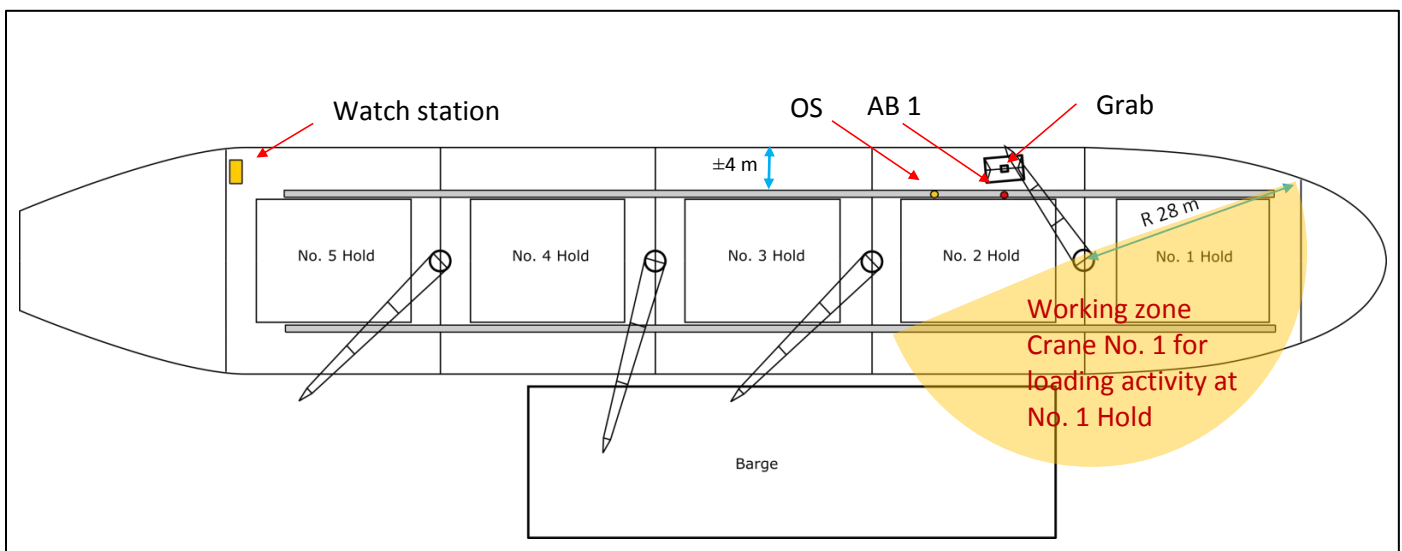
Figure 3: The illustration of the AB 1 position's

Because there was no response from the crane operator, AB 1 asked the OS to walk on the port side deck catwalk and approach Crane No. 1 until near Hatch No. 2 while continuing to signal the flashlight towards the operator's cabin. After near Hatch No. 2, AB 1 gave orders to the OS to stop and not to follow him. Then AB 1 continued to walk forward while still pointing the flashlight at the operator's cabin of the Crane No. 1.

At around 23.35 LT, when AB 1 was near the port side of Hatch No. 2 facing the crane and pointing his flashlight at the operator's cabin, Crane Operator No. 1 who got the flashlight signal decided to lift the grab. The grab moved up then swung to the port side hitting the ship's fence then swung to the starboard side crushing AB 1's back against

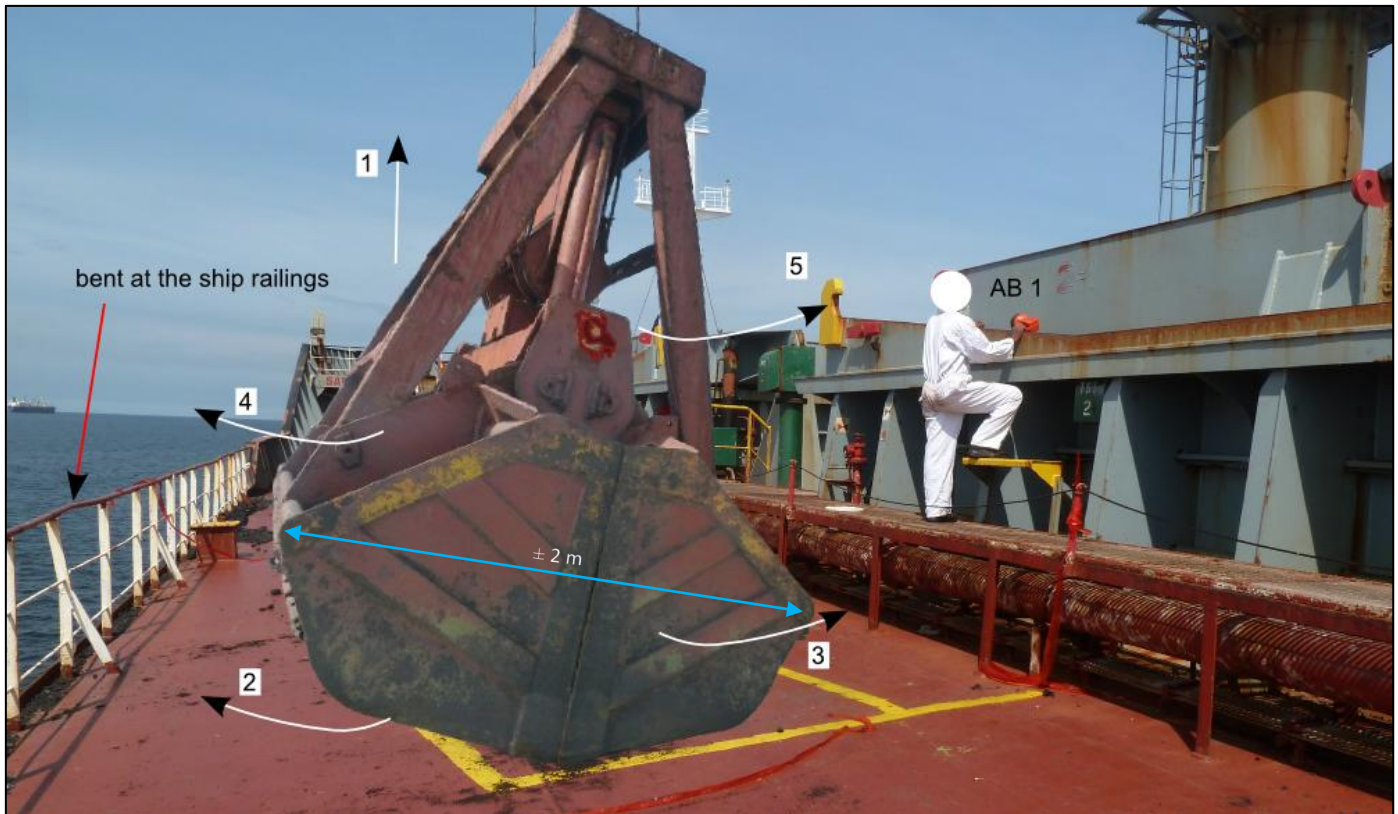
**Figure 4: Marks (yellow paint lines on the deck) Grab position in inclined position and AB 1 position with back to grab and illustration of grab movement sequence**

the side hatch coaming. The AB 1 then turned his body and the grab swung back again, crushing AB 1's chest against the side hatch coaming. Crane Operator No. 1 continued to lift the grab and placed the grab on the Hatch Cover No.2. After that, the Crane Operator No. 1 switched off the crane and went down to the port deck. At that time, the Kapokja Group 2 did not know what had happened because he was at the stern deck.

The position of Grab Crane No. 1 on the port deck was identified by police officers, who marked the trace with yellow paint, based on the coal remnants left on the deck. The investigation team also observed that the ship's port-side railing, near the marked grab position, was bent and the paint on the railing had peeled off. This damage likely indicates that the railing was struck by the grab during the incident.

At the time of the accident, AB 1 was crushed between the grab and the side of the hatch coaming. Before the incident, the grab in its closed position had been placed by Crane Operator No. 1 on the port side deck. Shortly before the accident, Crane Operator No. 1 lifted the grab without realizing that it was unstable. The grab hit the ship's railing and swung toward AB 1, who was subsequently crushed twice—once on the back and once on the chest. AB 1 was unaware that the grab had been lifted, as he was facing toward the crane operator's cabin with his back turned to the grab.

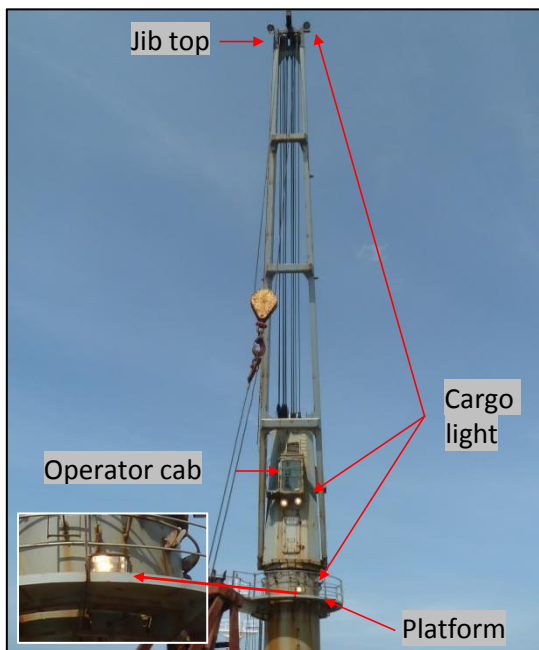
**Figure 5: Lights on the Crane No. 1 (insert: Light Blocked by the Platform)**

The *Mariner* crane is outfitted with cargo lightings to facilitate nighttime operations. Specifically, two 500 watt halogen lamps are installed under the crane cab and two additional 500 watt halogen lamps are positioned at the top of the jib. However, during investigation, the team discovered that two lights at the jib top were not functioning.

Lighting on the port side deck, near the incident area, is provided by several sources: a port-side deck light located on the side of the Hatch No. 2 coaming, a light near the slewing bearing of Crane No. 1, and two cargo lights beneath the crane housing. However, the crane platform obstructs lighting from the slewing bearing light, preventing it from illuminating the area beneath the crane (Figure 5).

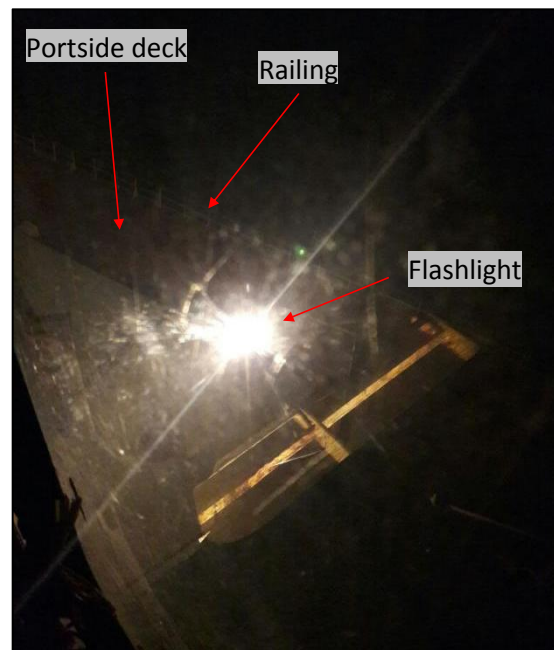
**Figure 6: Visual from inside the operator's cabin to the port side left deck at night**

During nighttime operations, the port side deck area around Hatch No. 2 remains dimly lit due to the lack of additional lighting sources in the anchored waters, aside from the ship's own lights. KNKT investigators captured

visual images from inside the operator's cabin looking toward the port side deck. When a flashlight was aimed at the cabin, the operator could clearly see the beam of the light but struggled to identify the person holding the flashlight or view the surrounding area clearly (Figure 6).

The limited lighting on the port side deck around Hatch No. 2 during night operations also contributed to the accident. Loading operations were conducted without external lighting, relying solely on the ship's lights. Two of the cargo lights at the end of Crane No. 1's jib were not functioning, and the cargo light under the crane housing was obstructed by the crane platform. In addition, AB 1's flashlight, which was directed toward the operator's cabin, may have further reduced visibility. These factors likely made it difficult for Crane Operator No. 1 to clearly see AB 1 on the port side deck from inside the cabin.

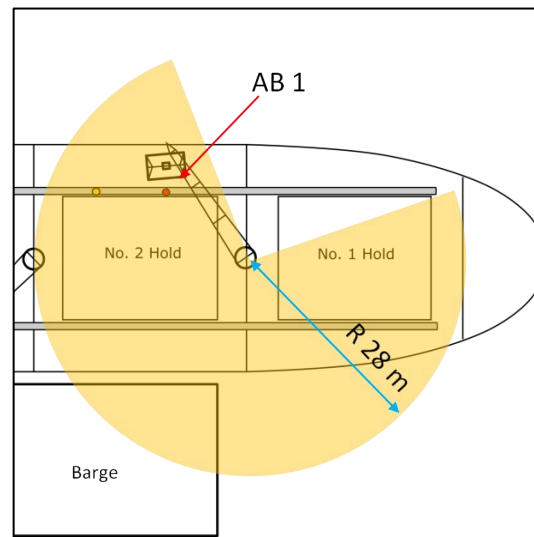
**Figure 7 Crane work zone No. 1 becomes wider than before**

During the loading process from the barge to Hold No. 1, the working zone of Crane No. 1 was primarily on the starboard side of the ship, covering the area from Hold No. 1, the starboard deck, and extending to the barge (see Figure 2). When the coal in the barge was depleted, Crane Operator No. 1 rested the grab by placing it on the port side deck. This action effectively expanded the crane's working zone (Figure 6). When AB 1 and the Ordinary Seaman (OS) approached Crane Operator No. 1 to request that the grab be moved to the starboard side, they unknowingly entered the crane's extended working zone, which had a radius of 28 meters. Although AB 1 instructed the OS not to follow him, AB 1 positioned himself directly under the jib, between the grab and Hatch No. 2, with his back turned to the grab, unaware that it was being lifted and swinging toward him.
