**KNKT.24.07.16.04**

## **Aircraft Accident Investigation Report**

**PT Whitesky Aviation**

**Bell 505; PK-WSP**

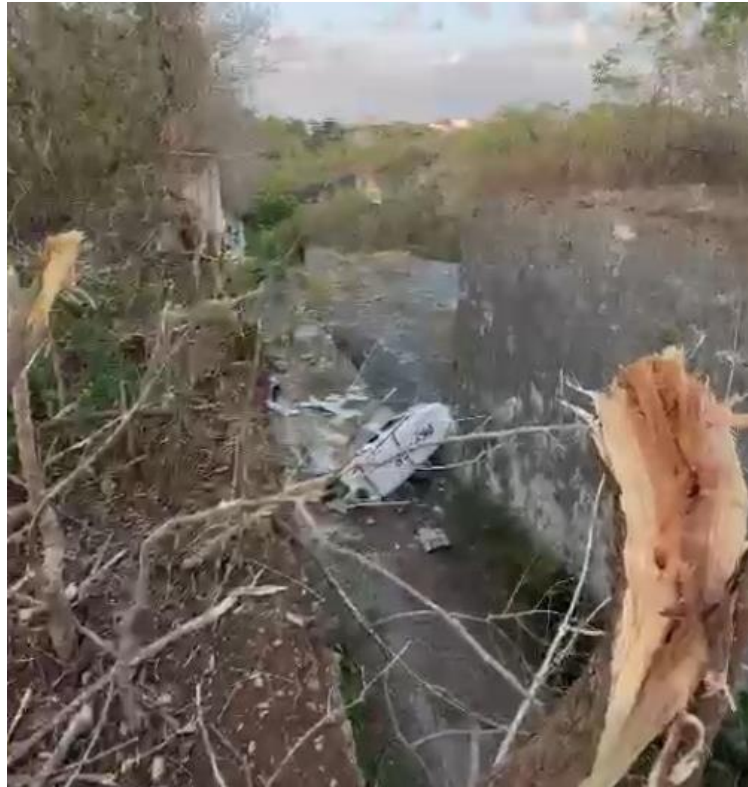
**Figure 4: The helicopter location seen from the incoming direction**

As seen in the figure 4 above, the main rotor cut several trees above the cliff before stop. The direction from the impact to the helicopter stop was about 030°.

Near the man-made cliff, there was an opening area (as shown in figure 4 above) that was the pilot target of the landing during the emergency situation.

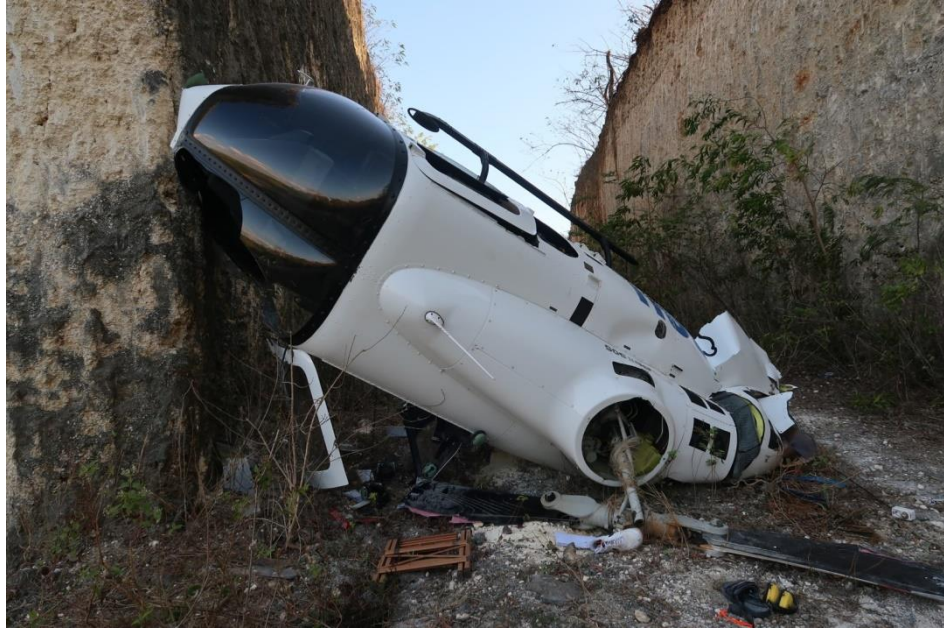
**Figure 5: The helicopter condition after impact**

The helicopter faced a heading of about 047°, with the windshield leaning about 45° on the ridge as shown in the figure below. The tail boom and tail rotor were separated and found about 5 meters from the helicopter.

The main rotor mast exhibited damage in which the main rotors were detached. Part of the main rotors was found about 20 meters from the main wreckage above the man-made cliff.

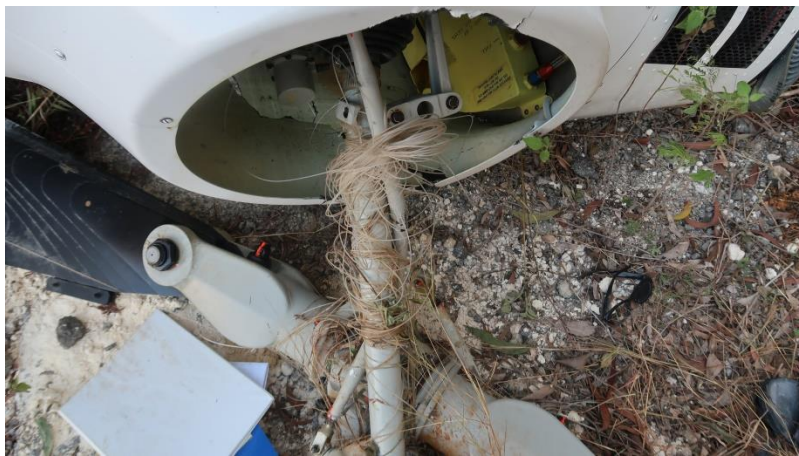
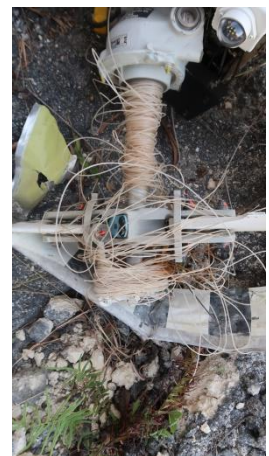
**Figure 6: The evidence of kite string on the main rotor and tail rotor mast.**

The evidence of the kite string wrapped around the main rotor mast led to the flight control rod being deformed. The tail rotor also exhibited damage and the evidence of the kite string was wrapped around the tail rotor mast.

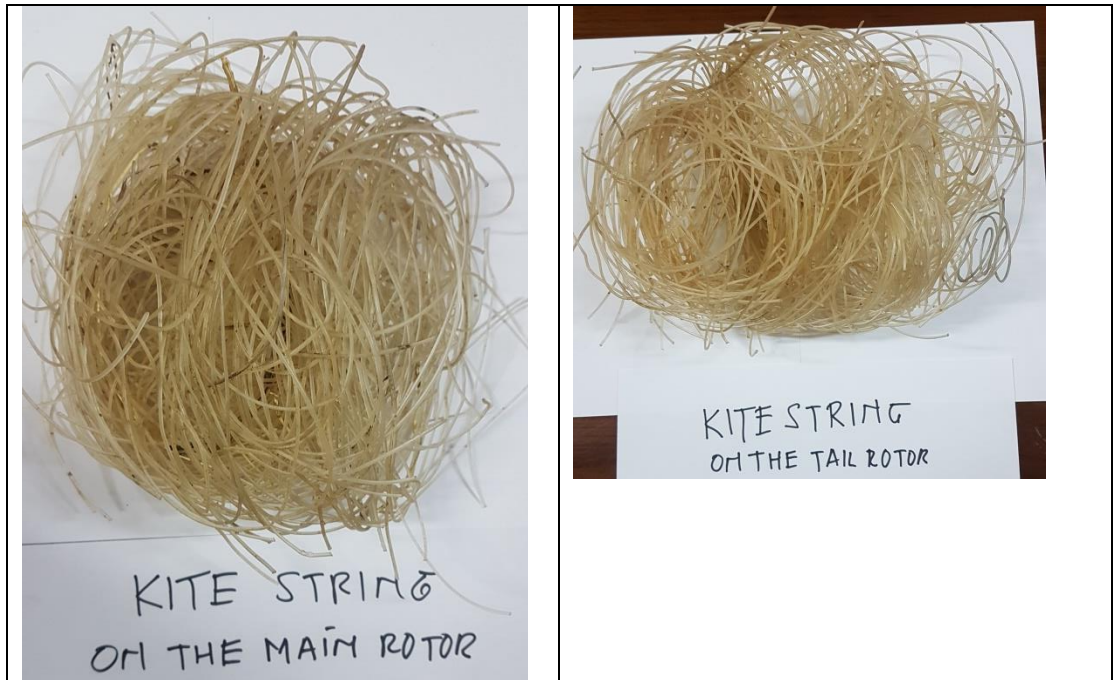
**Figure 7: The kite string on the main rotor and tail rotor**

The observation of the number of kite string turns in the main rotor was estimated more than 200 coils and in the tail rotor was estimated more than 120 coils.

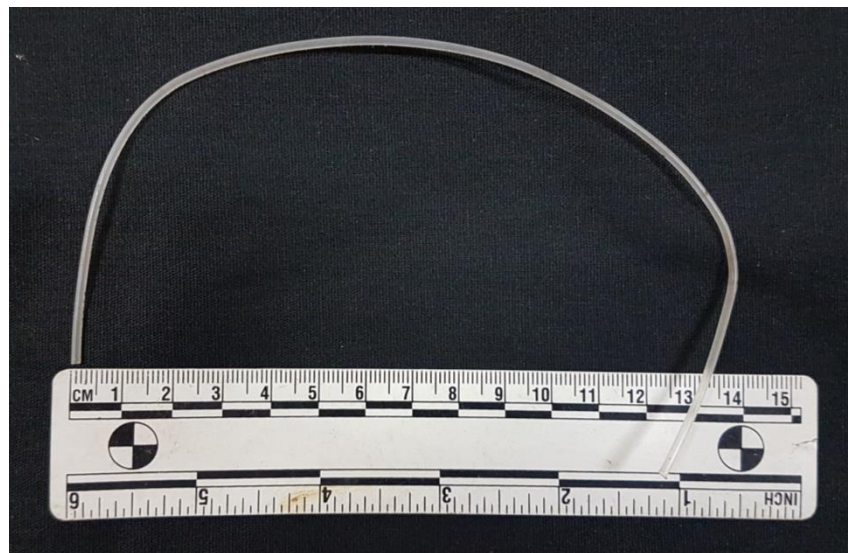
**Figure 8: The diameter of the kite string**

The diameter of the kite string was about 2 millimeters as shown in the figure below.

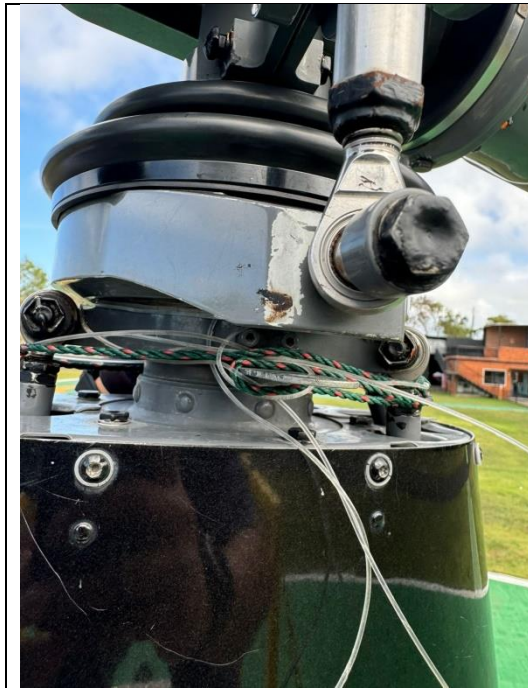
After landing, it was found that the main and tail rotor masts entangled by kite strings as shown in the figure below.

The kite string and plastic rope on the main rotor mast

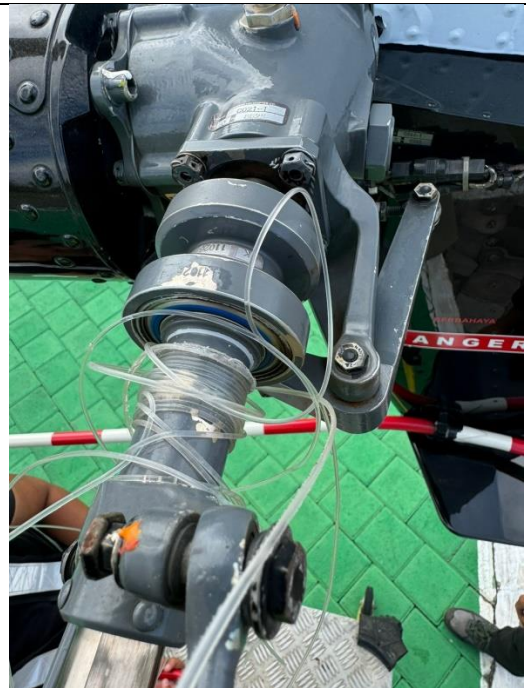
The kite string on the tail rotor mast

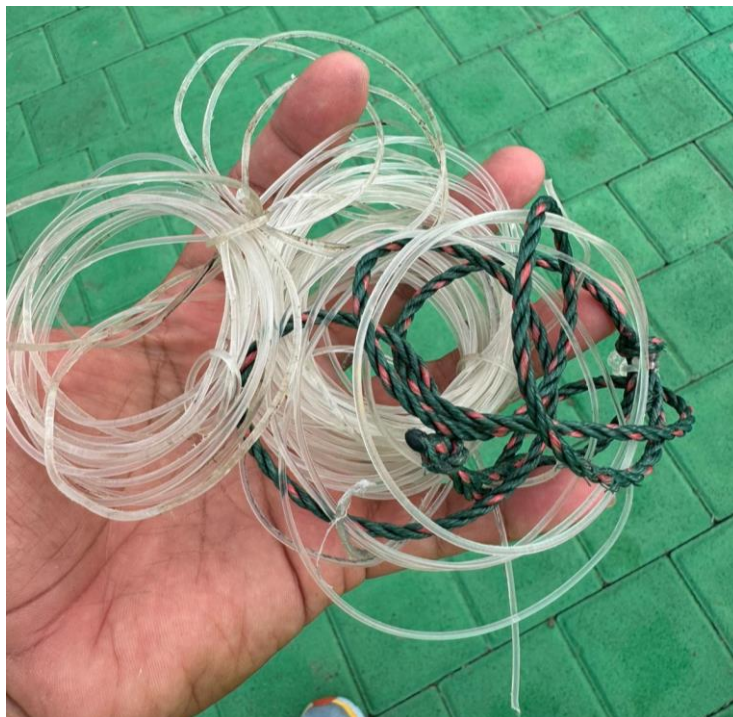
**Figure 10: The kite string and plastic rope that were removed from main rotor and tail rotor masts**

The diameter of the kite string was similar to the PK-WSP occurrence. The dimension of the plastic rope was estimated about twice compared with the kite string.

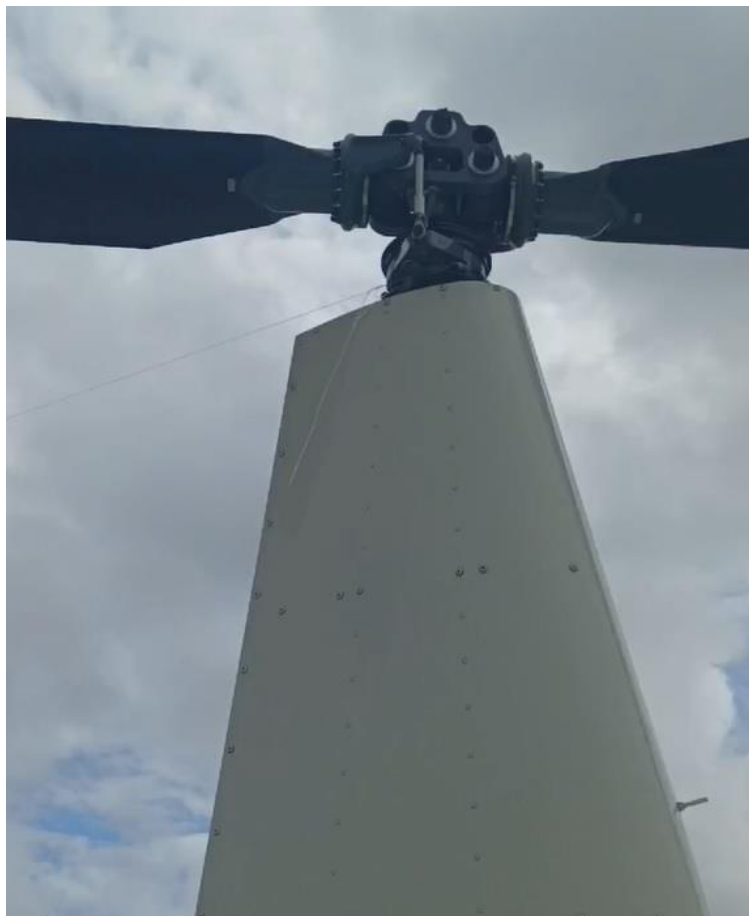
**Figure 11: The PK-VPN kite strike occurrence**

After landing, the radio operator advised the pilot that the main and tail rotor masts wrapped by kite strings as shown in the figure below.

No one was injured in this occurrence and no damage found on the helicopter.
