**KOMITE NASIONAL KESELAMATAN TRANSPORTASI  
REPUBLIC OF INDONESIA**

**Aircraft Accident Investigation Report**

**MBB BK-117 D3; PK-RGH**

**Mantewe, Tanah Bumbu, South Kalimantan**

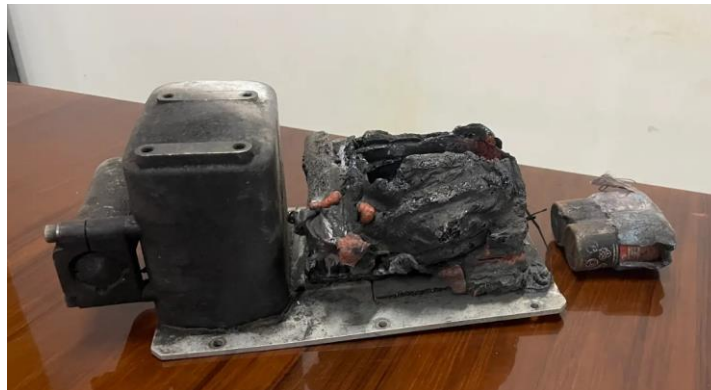
**Figure 3: The CVFDR recovered from the accident site**

The aircraft was equipped with an FA5000 Cockpit Voice Flight Data Recorder (CVFDR) manufactured by L3 Aviation Recorders, Part Number 5001-6103-11, Serial Number 00154248. The recorder was recovered from the accident site in a severely damaged condition and subsequently transported to the KNKT recorder facility for further examination.

The examination determined that the recorder required a specialized readout chassis to perform data extraction, which was not available at the KNKT facility. Therefore, KNKT plans to transport the damaged recorder to the Australian Transport Safety Bureau (ATSB) recorder facility, which has the capability to conduct the readout.

8. Satellite imagery indicated the presence of mid- to high-level clouds in the vicinity of the occurrence area.
9. The aircraft was equipped with a CVFDR, which was recovered from the accident site in a severely damaged condition.

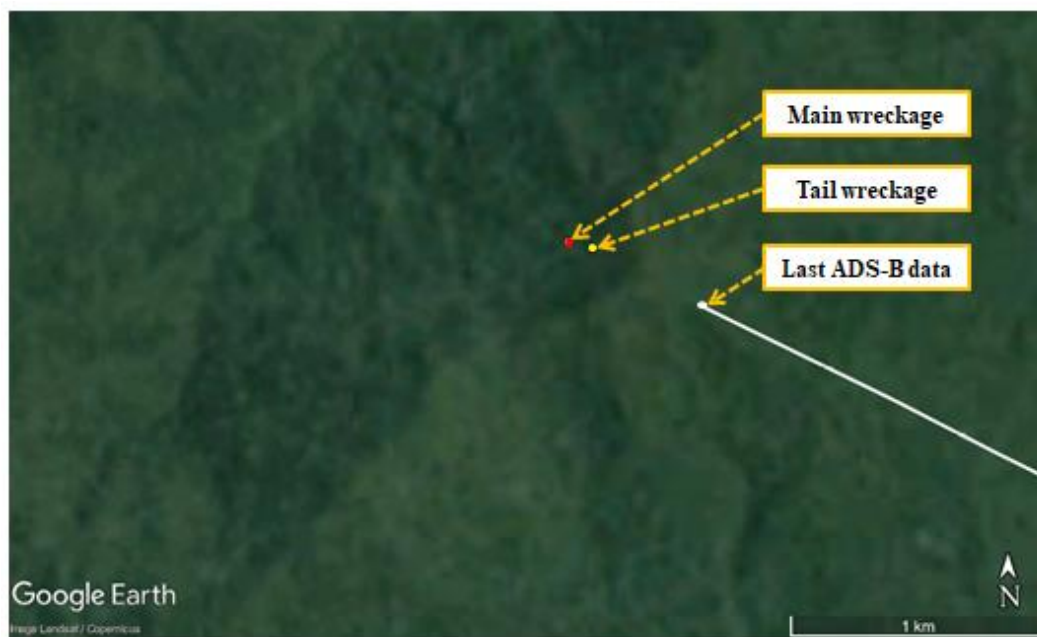
Figure 4: The wreckage positions

The accident site was located in a mountainous area with steep and difficult-to-access terrain. The first point of impact had not been determined at the time of examination. The wreckage was found in two main sections, with the tail section located separately uphill. The horizontal distance between the main wreckage and the tail section was approximately 100 meters.

The main wreckage was located at an elevation of about 2,200 ft, at coordinates 03°05'06.00" S, 115°37'39.70" E, on a heading of approximately 270°. The tail section was found at coordinates 03°05'06.71" S, 115°37'42.62" E, at an elevation of about 2,400 ft.

17. On 3 September 2025, the main wreckage was located on a ridgeline approximately 600 meters from the last recorded ADS-B point.
18. The main wreckage was located at an elevation of about 2,200 ft, at coordinates 03°05'06.00" S, 115°37'39.70" E, on a heading of approximately 270°. The tail section was found at coordinates 03°05'06.71" S, 115°37'42.62" E, at an elevation of about 2,400 ft.
