PRELIMINARY  
KNKT.15.08.17.04

Aircraft Accident Investigation Report

**PT. Trigana Air Service  
ATR 42-300; PK-YRN  
Near Oksibil, Papua  
Republic of Indonesia  
16 August 2015**

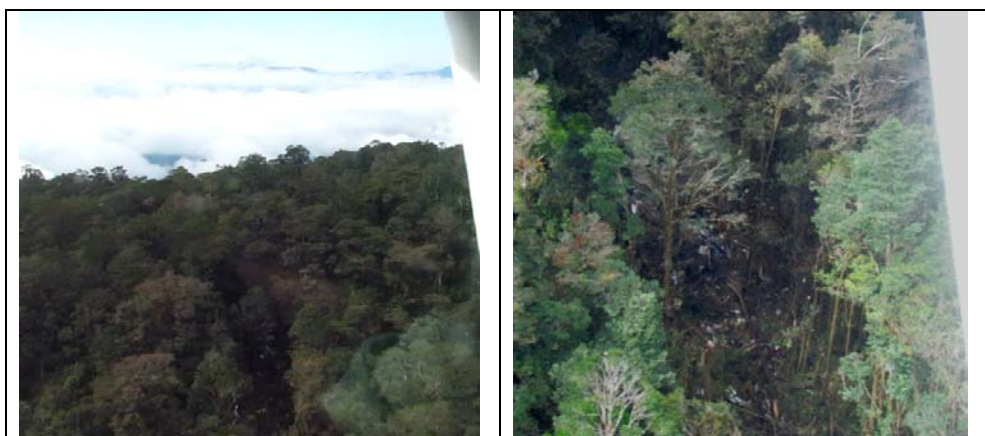
**Figure 3: The accident site pictures taken from an aircraft**

The aircraft wreckage was found on a ridge of Tanggo Mountain, Okbape District, Oksibil at approximately 8,300 feet AMSL at coordinates of 04° 49.289'S, 140°29.953'E, approximately 10 NM from Oksibil Aerodrome on bearing of 306°.

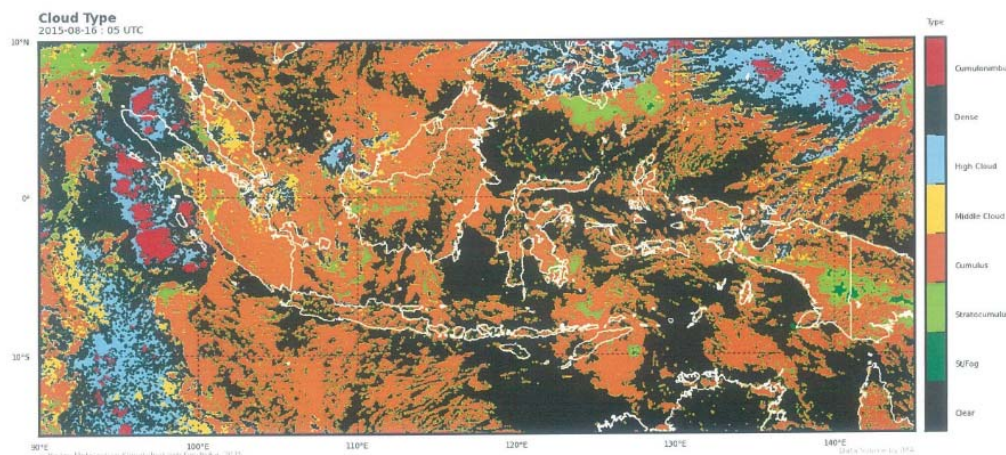
**Figure 4: The satellite weather image at 0500 UTC**

Wind : 110 / 08 knots  
Visibility : 4000 m – 5000m  
Weather : Nil  
Cloud : BKN (broken) <sup>3</sup>8000 feet (4000 AGL)

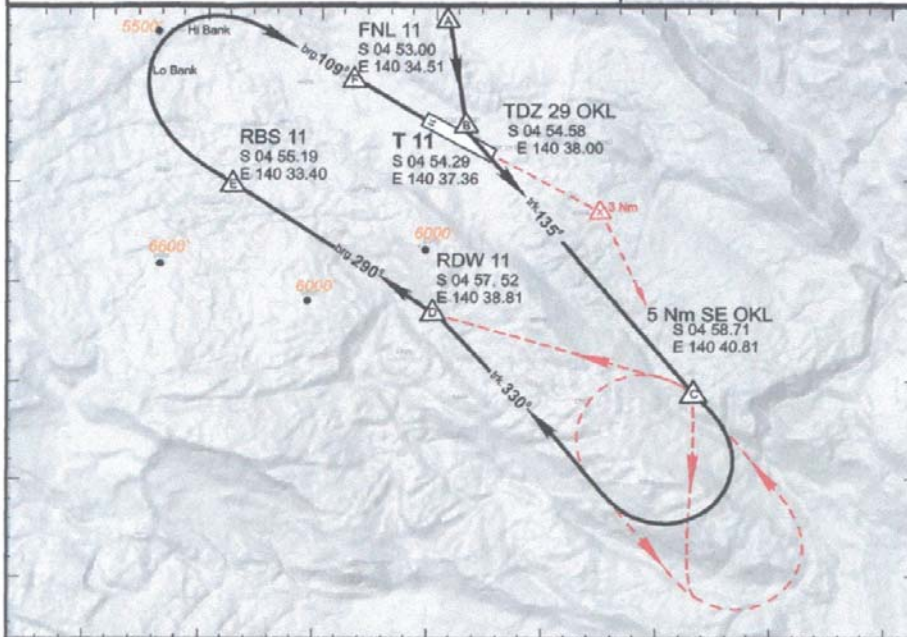
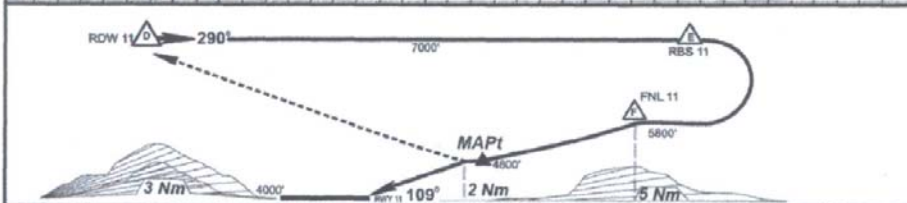
**Figure 5: Visual approach chart guidance issued by the operator**

## Visual Guidance Circling Approach Rwy 11

Go Around Maintain Rwy Heading Until 3 Nm leaving Tdz 29 and continue climb, making right turn proceed to 5 Nm SE OKL.

- A. Start descend from 10 Nm OKL with speed 160 kts, ROD 1000ft/min descend to 10000 ft until overhead OKL, (TQ setting  $\pm 10\% - 15\%$ ).
- B. 1 Nm before OKL turn left to heading 135° proceed to 5 Nm SE OKL and continue to 8500 ft with speed 160 kts and ROD 1000 ft/min.

- C. At point 5 Nm OKL turn right (high bank) heading 330° proceed to point RDW 11, continue descend with speed 160 kt to 7000 ft and maintain altitude.

- D. At 0,5 Nm before point RDW 11 left turn to heading 290° (Hi bank) for intercepting bearing 290° RBS 11, Maintain altitude 7000 ft until point RBS 11, maintain speed 140 kts then select flaps 15 (TQ setting  $\pm 35\% - 40\%$ ), Monitor RA minimum 2000 ft.

- E. At point RBS 11 select L/D gear down (*check three green down and lock*) then continue start turning Low Bank to initial heading 090° for intercepting bearing 109° Tdz 11 and continue descend to 5800 ft with speed 130 kts ROD 1000 ft/mn. (*set GPS to TDZ 11*).

- F. At point FNL 11 (5 Nm Tdz 11) with target altitude 5800 ft select flaps 30 and CL maximum, and continue descend to 4800 ft, ROD 1000 ft/m with Vapp + 5 kts.

MApt : At Mapt, 2 Nm, Alt 4800 ft with bearing 109° from Tdz 11 Approach  
(*Must be Stabilized*).

Oksibil airport equipped with a Non- Directional Beacon (NDB) identify as ZX on frequency 342 MHz. There was no instrument approach procedure published for this airport.

The air operator issued visual guidance approach for internal use.

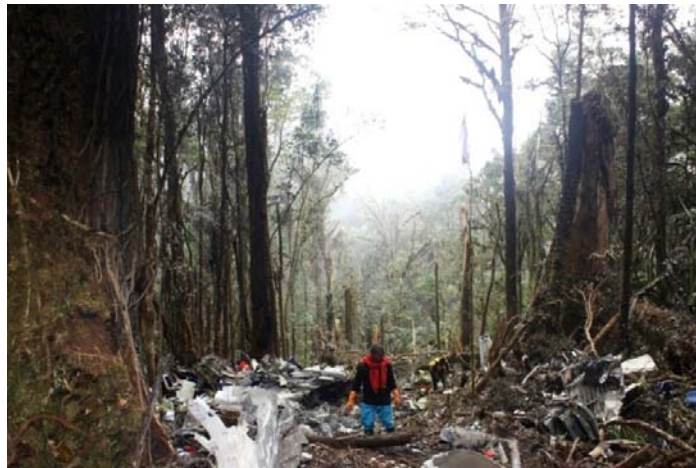
**Figure 6: The view from the accident side toward the aircraft flight path**

According to the information of the pilot observing the accident site, the wreckage distributed on direction approximately 195°-200°.

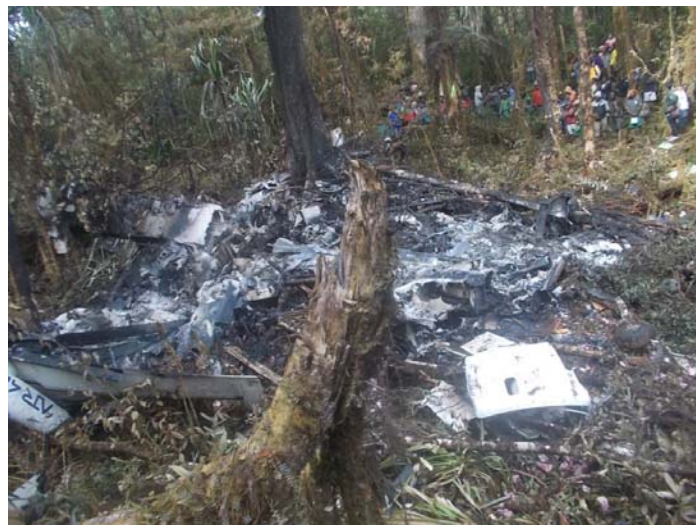
**Figure 7: The wreckage of the fuselage damaged by post-impact fire**

The area of the aircraft fuselage debris was destroyed by post impact fire.
