PRELIMINARY  
KNKT.15.12.28.04

Aircraft Accident Investigation Report

**PT. KalStar Aviation  
Embraer 190-200LR; PK-KDC  
El Tari Airport  
Kupang, Nusa Tenggara Timur  
Republic of Indonesia  
21 December 2015**

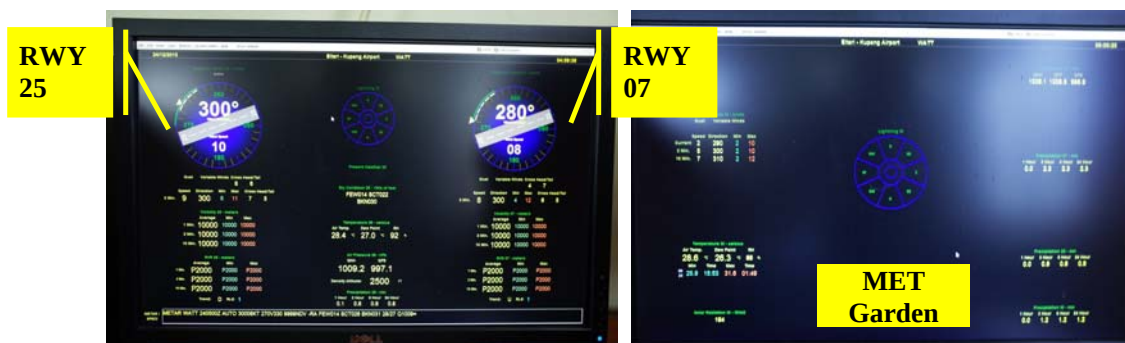
Figure 3: The display of AWOS

The AWOS information displayed in Meteorology Station office and also in El Tari Tower station. The display showed information according to its sensor location, which were labeled 07, 25 and M (figure 3).

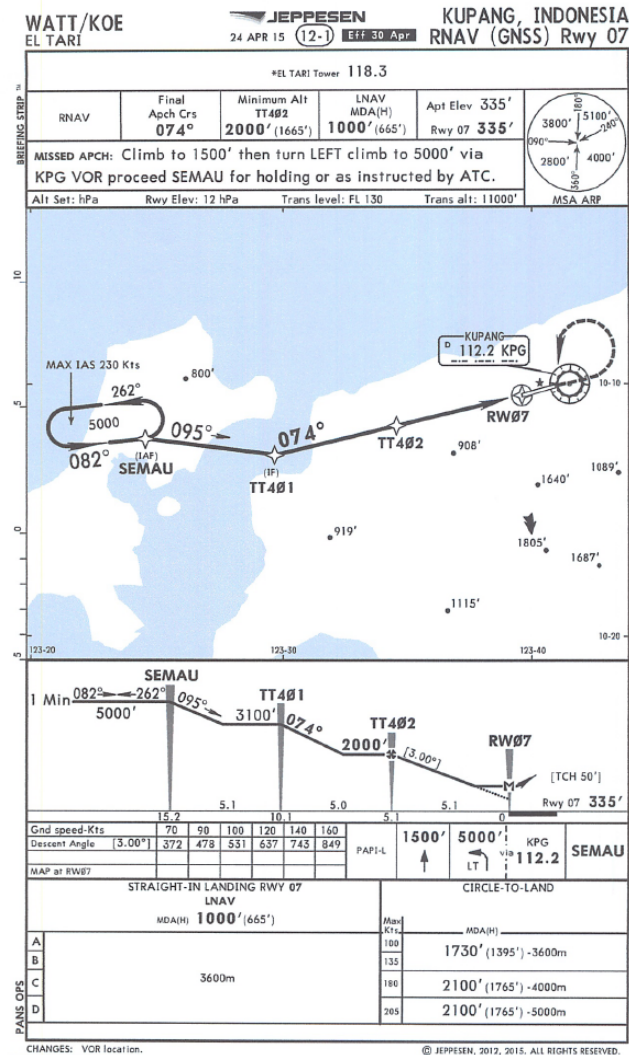
**Figure 7: RNAV approach runway 07 chart published by Jeppesen**

Runway 07 Kupang equipped with Global Navigation Satellite System (GNSS) that can be used for RNAV Approach since 25 August 2012. The detail of RNAV Approach can be seen figure 7.

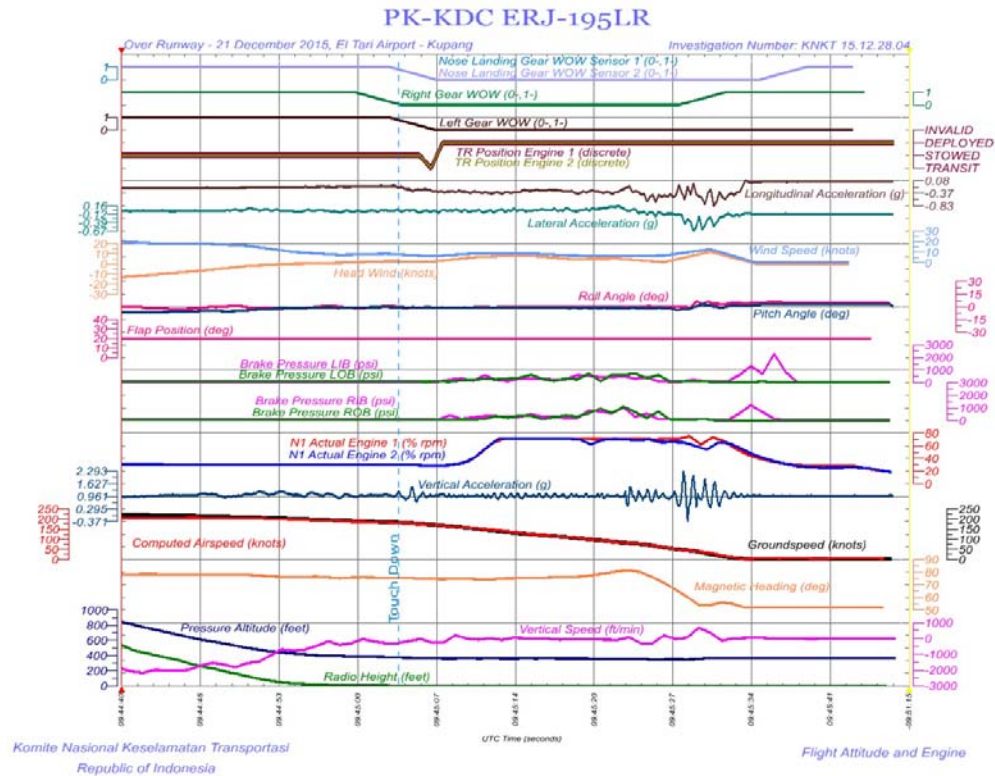
Figure 8: The graph of several flight data parameters

The DVDR data have been successfully downloaded and contain 25 hours of 900 flight data parameters and two hours of cockpit voice recording which include the accident flight.

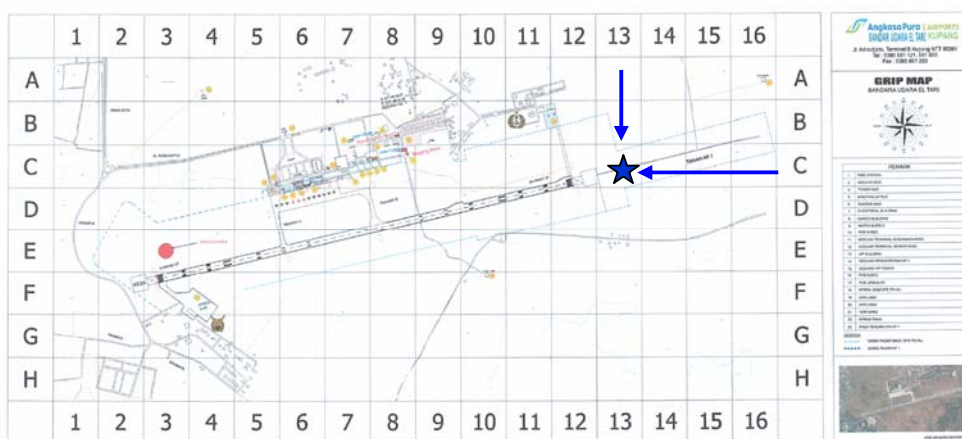
**Figure 13: The aircraft location on grid map**

At 0946 UTC, the El Tari Tower controller noticed that the aircraft overrun and pushed the crash bell to inform the Aircraft Rescue and Fire Fighting (ARFF) personnel. The controller then called the ARFF personnel and informed that there was aircraft overrun from runway 07 on sector C13 of grid map (figure 13). The ARFF then deployed three vehicles.
