**KOMITE NASIONAL KESELAMATAN TRANSPORTASI  
REPUBLIC OF INDONESIA**

## **KNKT16.05.14.04**

### **Aircraft Serious Incident Investigation Report**

**Hong Kong Airlines  
Airbus 330-223; B-LNE  
Near Banjarmasin  
Republic of Indonesia  
6 May 2016**

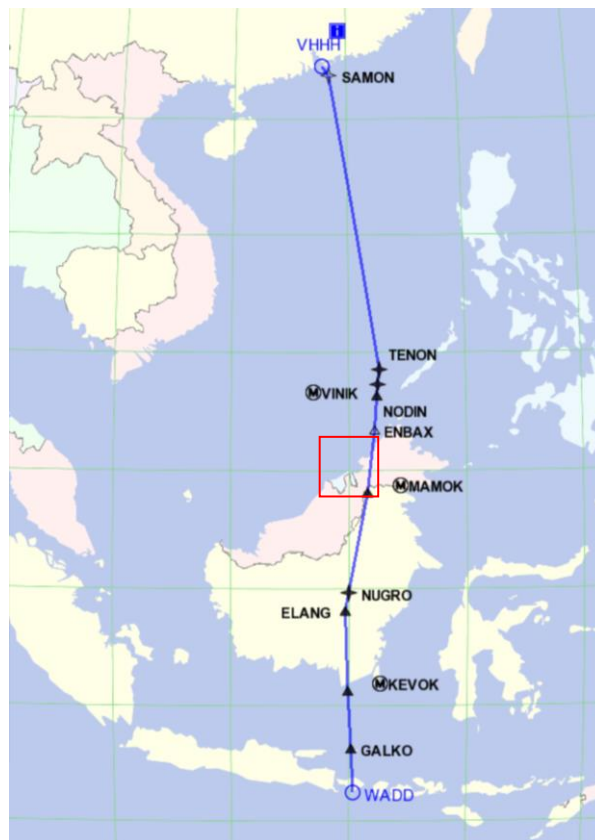
**Figure 1: The flight plan route and the area of turbulence (red box)**

During the preflight, the pilots noted the forecast weather chart which depicted significant clouds over Kalimantan Island surrounding the planned route of M522. Considering the weather, the pilots requested additional fuel to anticipate route deviation. The pilot also informed to the flight attendants, that the flight would encounter turbulence about one hour after departure and if the seatbelt sign was on, the flight attendants shall make sure that the passengers fastened their seatbelt.

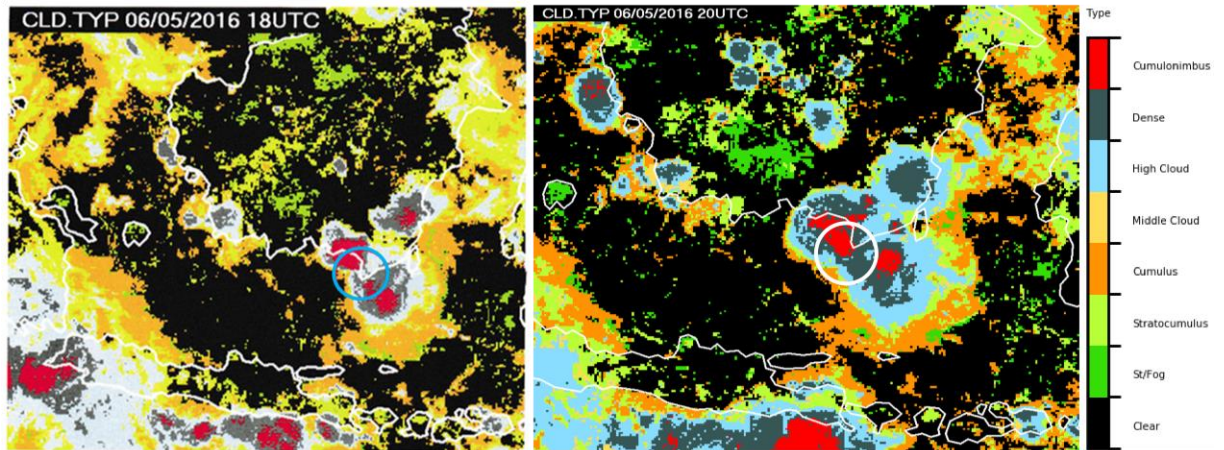
**Figure 3: Clouds type satellite imagery on occurrence area at 1800 UTC (blue circle) and at 2000 UTC (white circle)**

The satellite image of clouds type at 1800 UTC indicated two buildup cumulonimbus clouds at the occurrence location and the distance between the buildup cumulonimbus clouds was about 25 Nm. At 2000 UTC, the satellite image also indicated two buildup cumulonimbus clouds and the distance between the buildup cumulonimbus clouds was about 30 Nm

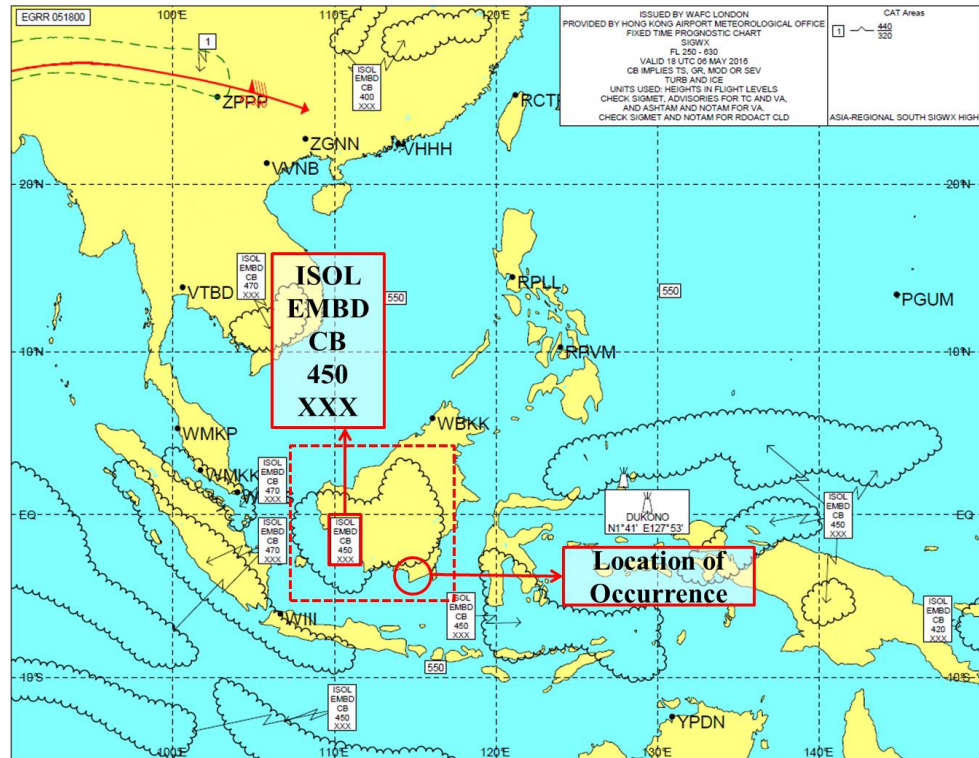
**Figure 4: Prognosis chart FL250-630 valid for 6 May 2016 at 1800 UTC**

The prognosis chart issued on 6 May 2016 at 1800 UTC showed the area of potentially develop isolated embedded cumulonimbus clouds was over most of Kalimantan including the occurrence area.

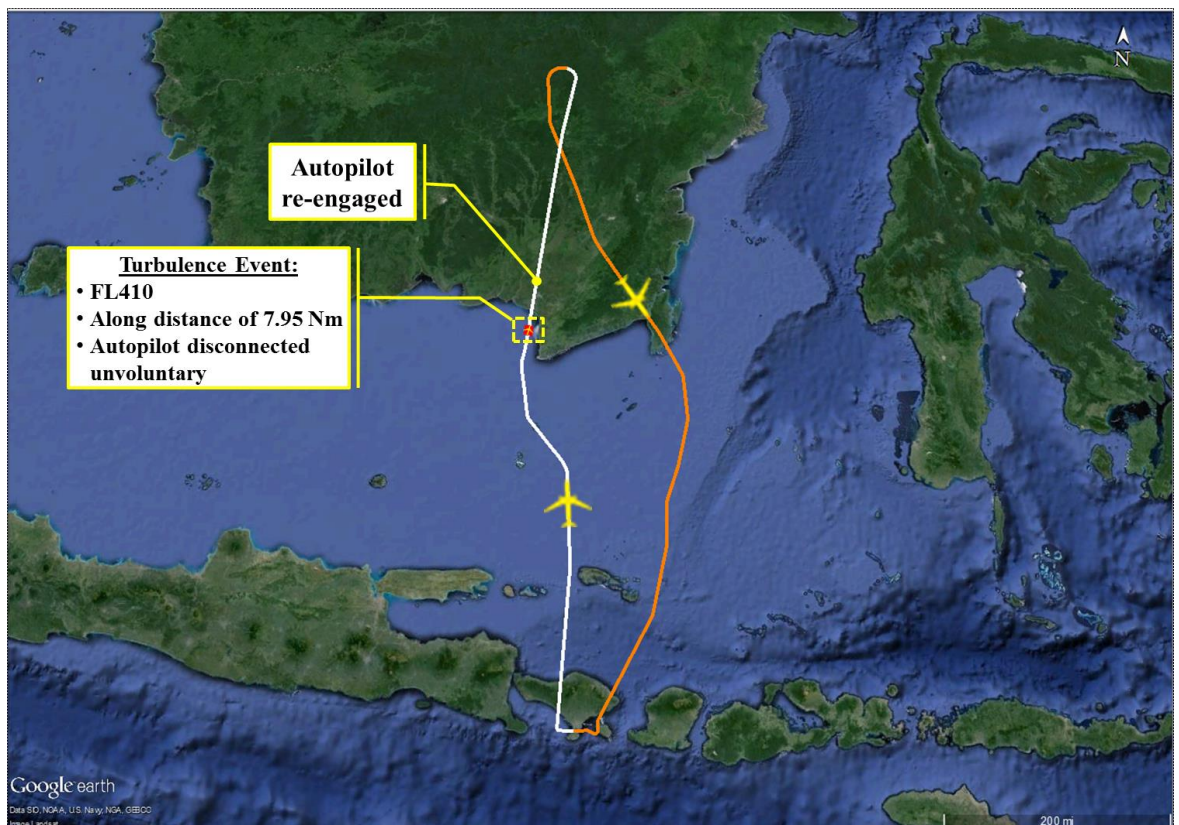
**Figure 7: Aircraft flight track based on FDR data**

The recorded parameters of latitude and longitude from the FDR were superimposed with the Google Earth (figure 7) and the satellite image to provide actual flight track during the occurrence (figure 8 and 9).
