**KNKT.23.05.05.04**

**Aircraft Accident Investigation Report**

**Cessna C208; PK-HVG**

**Yabi Airstrip, Papua**

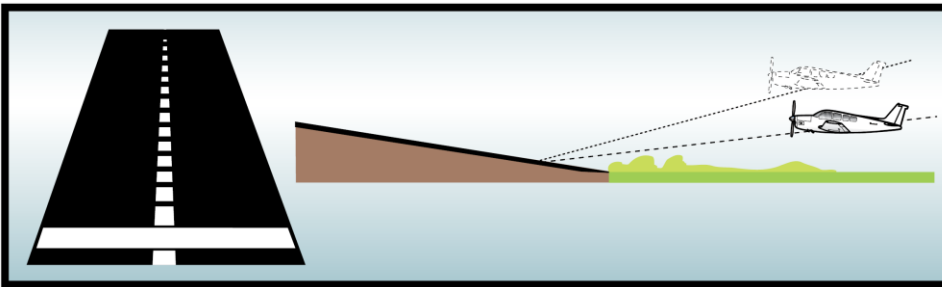
*A final approach over a flat terrain with an upsloping runway may produce the visual illusion of a high-altitude final approach. If you believe this illusion, you may respond by pitching the aircraft nose down to decrease the altitude, which, if performed too close to the ground, may result in an accident (Figure 3).*

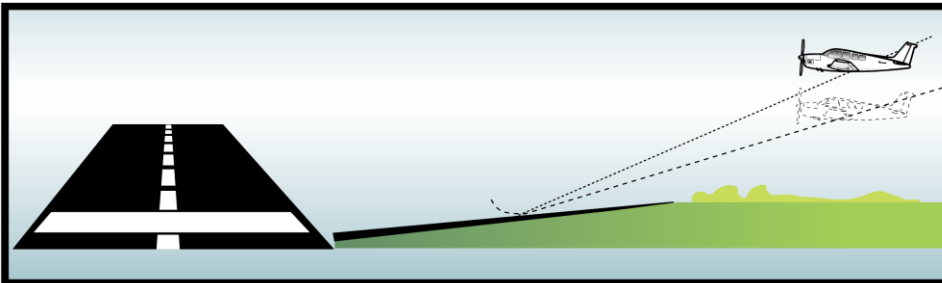
*A final approach over a flat terrain with a downsloping runway may produce the visual illusion of a low-altitude final approach. If you believe this illusion, you may respond by pitching the aircraft nose up to increase the altitude, which may result in a low-altitude stall or missed approach (Figure 4).*
