**KOMITE NASIONAL KESELAMATAN TRANSPORTASI  
REPUBLIC OF INDONESIA**

**Aircraft Accident Investigation Report**

**MBB BK-117 D3; PK-RGH**

**Mantewe, Tanah Bumbu, South Kalimantan**

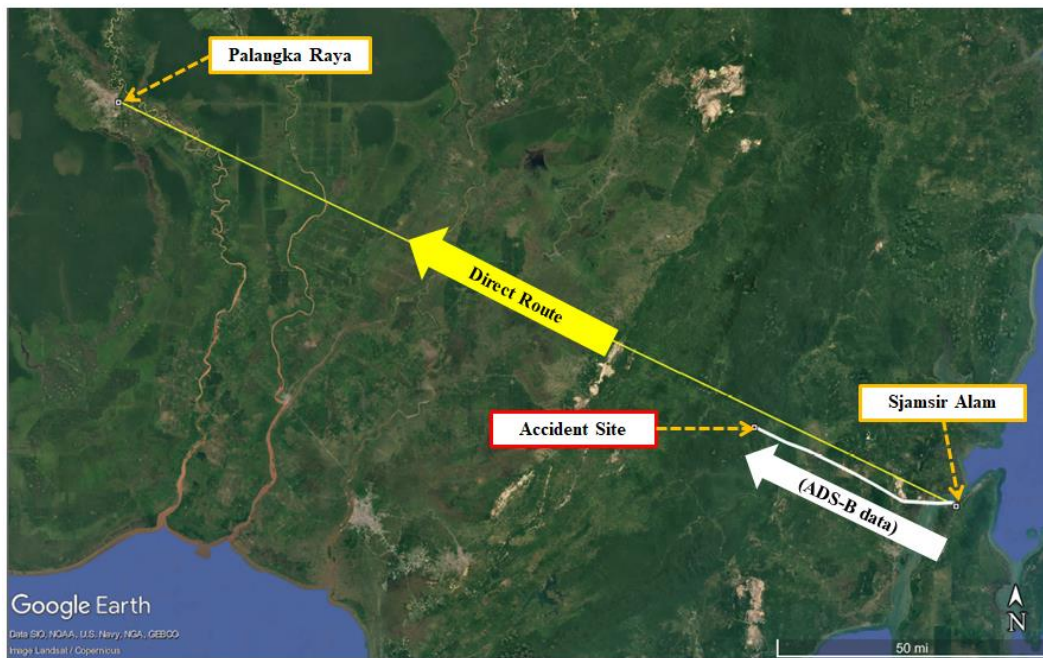
**Figure 1: The flight route**

The operator reported that at 0901 LT, the aircraft transmitted its final position via Spidertracks<sup>6</sup>. At that time, the aircraft was at an altitude of 2,422 ft, flying at a speed of 117 knots, on a heading of 297°, and located at coordinates 3°6'54.58" S, 115°41'21.62" E.

The last recorded Automatic Dependent Surveillance-Broadcast (ADS-B)<sup>7</sup> data, at 0903 LT, indicated the aircraft at an altitude of 2,725 ft with a groundspeed of 118 kt, on a heading of 295°, at coordinates 03°05'14.10" S, 115°37'56.40" E.

After several days of search operations, on 3 September 2025, the wreckage of PK-RGH was located on a ridgeline approximately 600 meters from the last recorded ADS-B point, at an elevation of about 2,200 ft above mean sea level (AMSL). The aircraft came to rest on a heading of approximately 270°, at coordinates 03°05'06.00" S, 115°37'39.70" E. The tail section was found separately at coordinates 03°05'06.71" S, 115°37'42.62" E, at an elevation of approximately 2,400 ft AMSL.

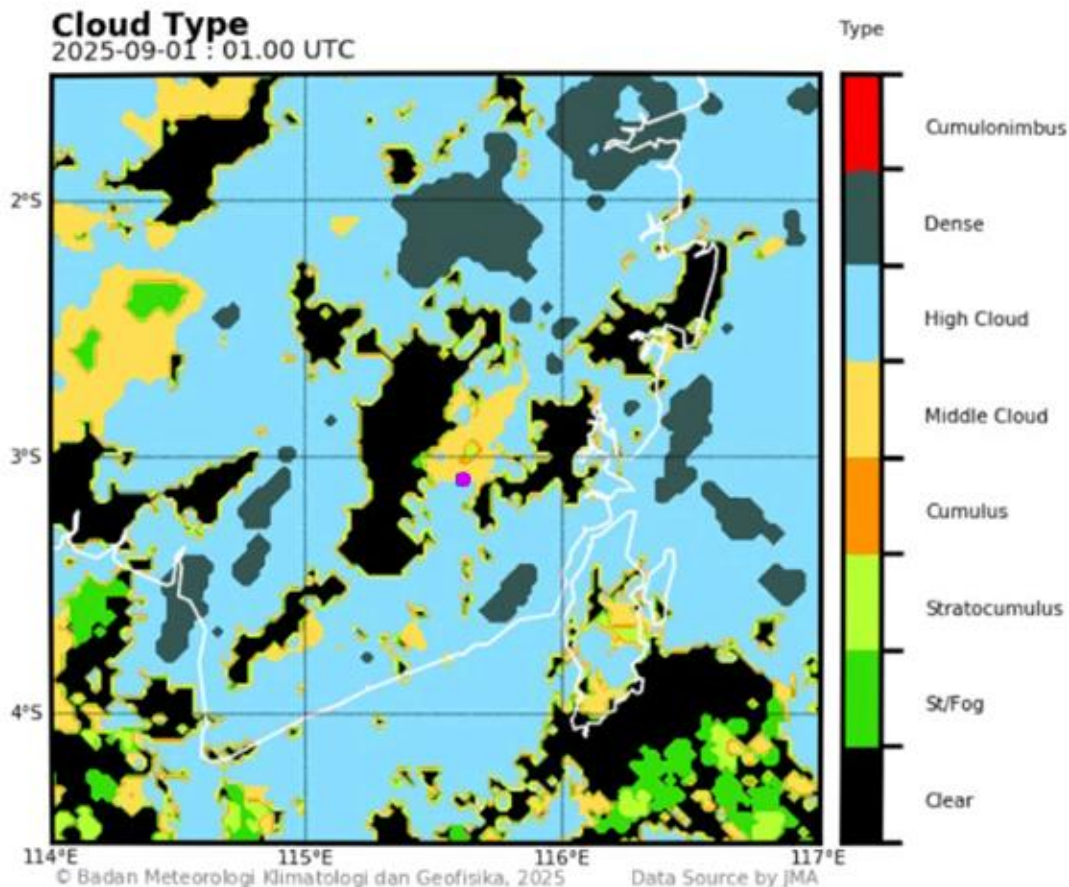
Figure 2: Satellite Imagery HCAI Cloud Type

Meteorological data were obtained from the *Badan Meteorologi, Klimatologi, dan Geofisika* (BMKG – Meteorology, Climatology, and Geophysical Agency of Indonesia). Figure 2 shows Himawari satellite imagery at 0900 LT (0100 UTC), indicating the presence of mid- to high-level clouds in the vicinity of the occurrence area. The purple circle in the figure indicates the vicinity of the accident site.

8. Satellite imagery indicated the presence of mid- to high-level clouds in the vicinity of the occurrence area.
9. The aircraft was equipped with a CVFDR, which was recovered from the accident site in a severely damaged condition.

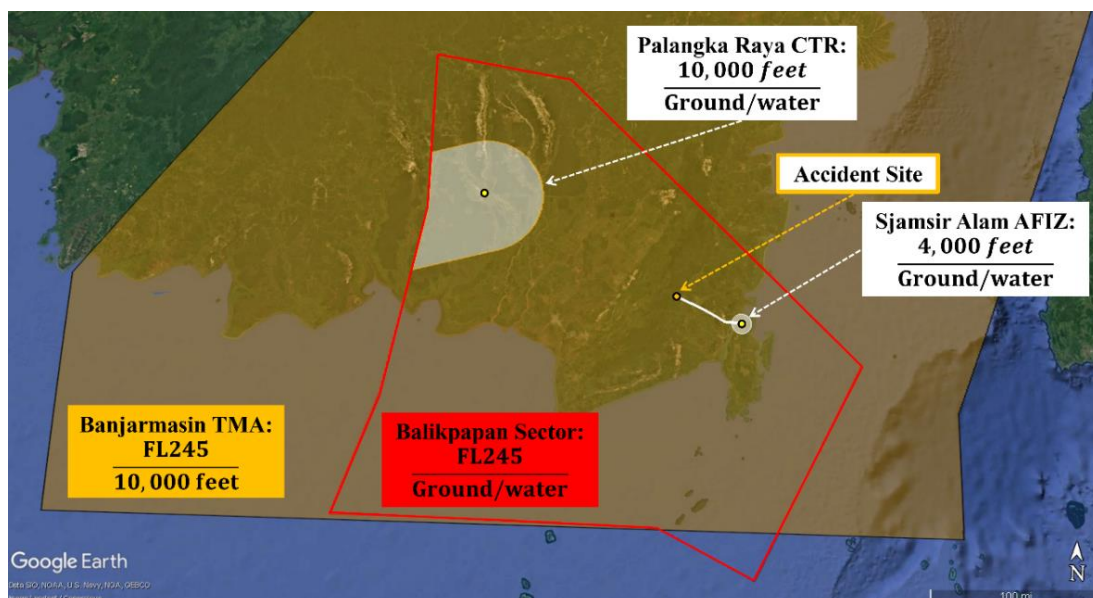
**Figure 5: The airspace designation**

The airspace classification in the Sjamsir Alam AFIZ and Balikpapan Sector are designated as uncontrolled airspace (Class G), while the Banjarmasin TMA is controlled airspace (Class B).

Flight information services within the Sjamsir Alam AFIZ are provided within 5 NM radius from Sjamsir Alam Aerodrome Reference Point (ARP), with vertical extending from the surface (ground/water) up to 4,000 ft. Beyond this area, aircraft enters the Balikpapan Sector, as the lower limit for Banjarmasin TMA was 10,000 ft. The airspace designations are illustrated in the Figure 5.
